City of Angleton, Texas

Americans with Disabilities Act (ADA) Self-Evaluation & Transition Plan

September 2022

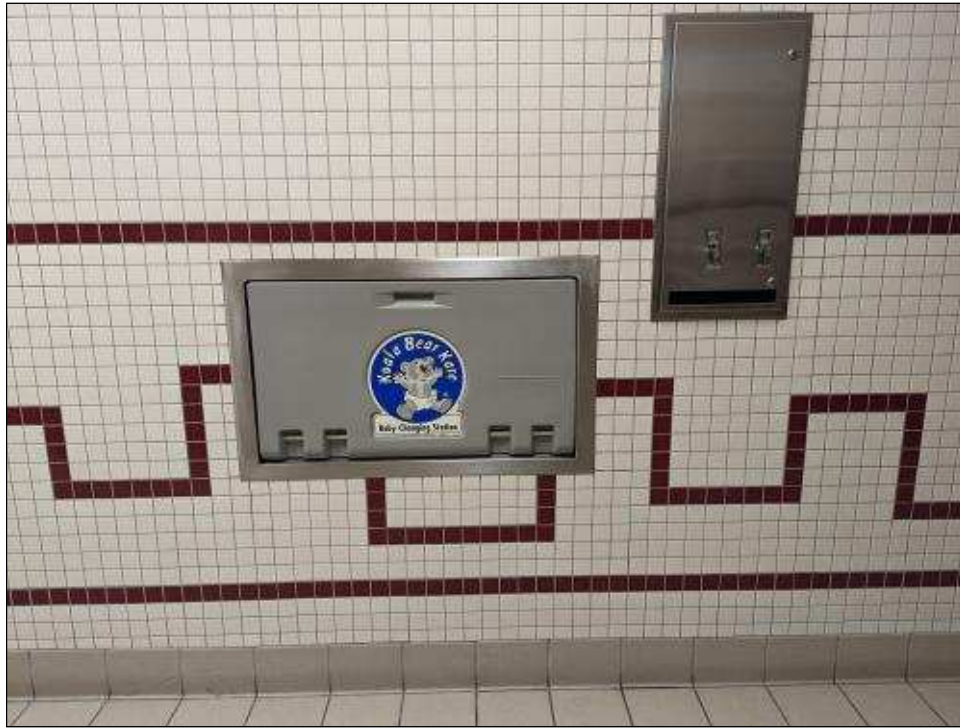
Barrier: 9

Restrooms: Women's Restrooms

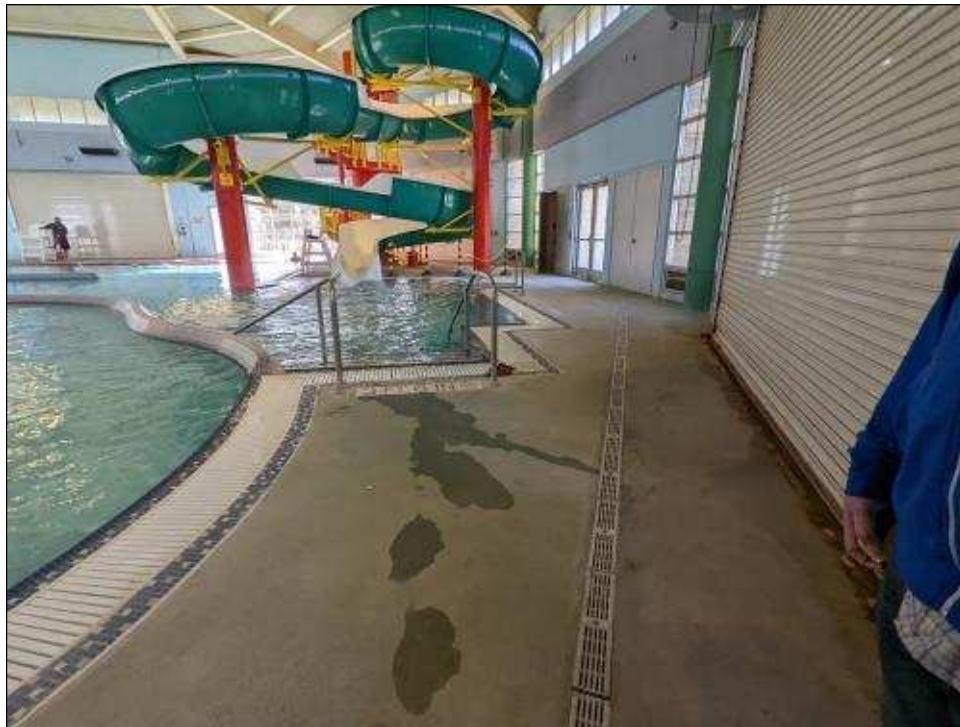
Barrier: 18

Pool Area: Path of Travel

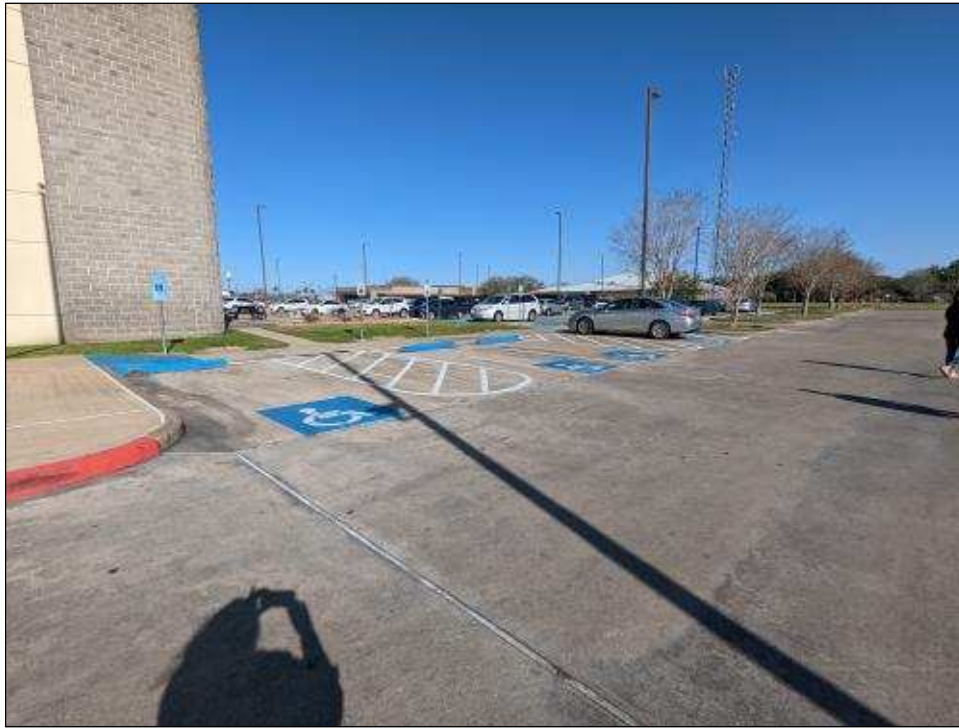
Barrier: 23

Exterior: Parking Lot

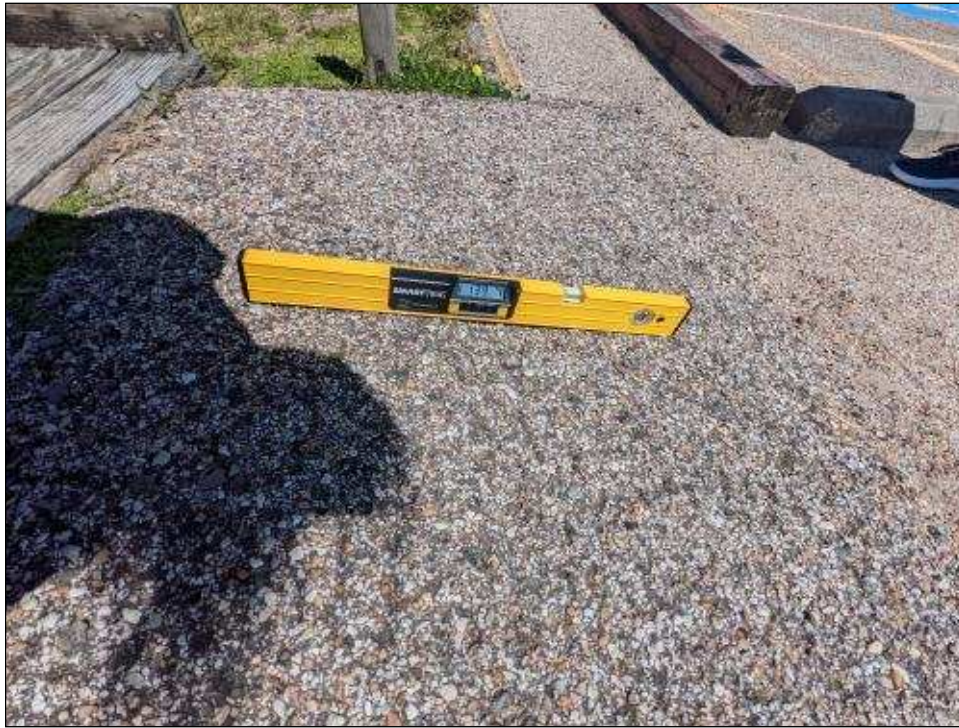
Barrier: 5

Accessible Route: Path of Travel

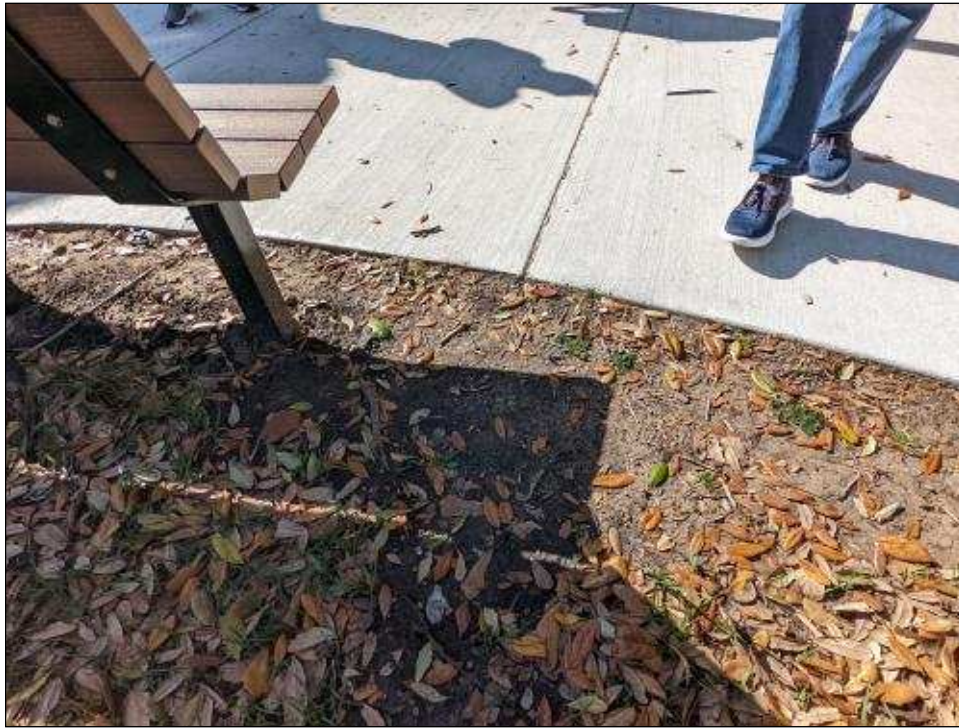
Barrier: 4

Playground: Playground Equipment

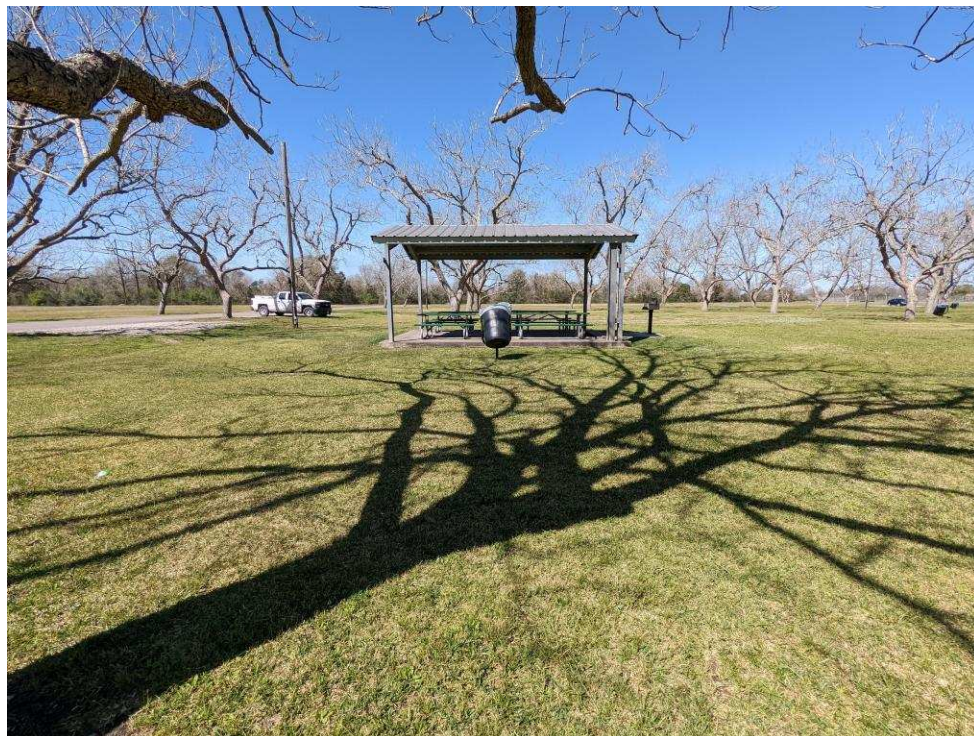
Barrier: 5

Pavillion: Accessible Route

Add at least 5% (minimum of 1) fully accessible picnic tables at each area where picnic tables are offered. Provide an accessible route that has a level, firm, stable, and slip resistant ground surface, and provide proper connection to any areas with a level change.

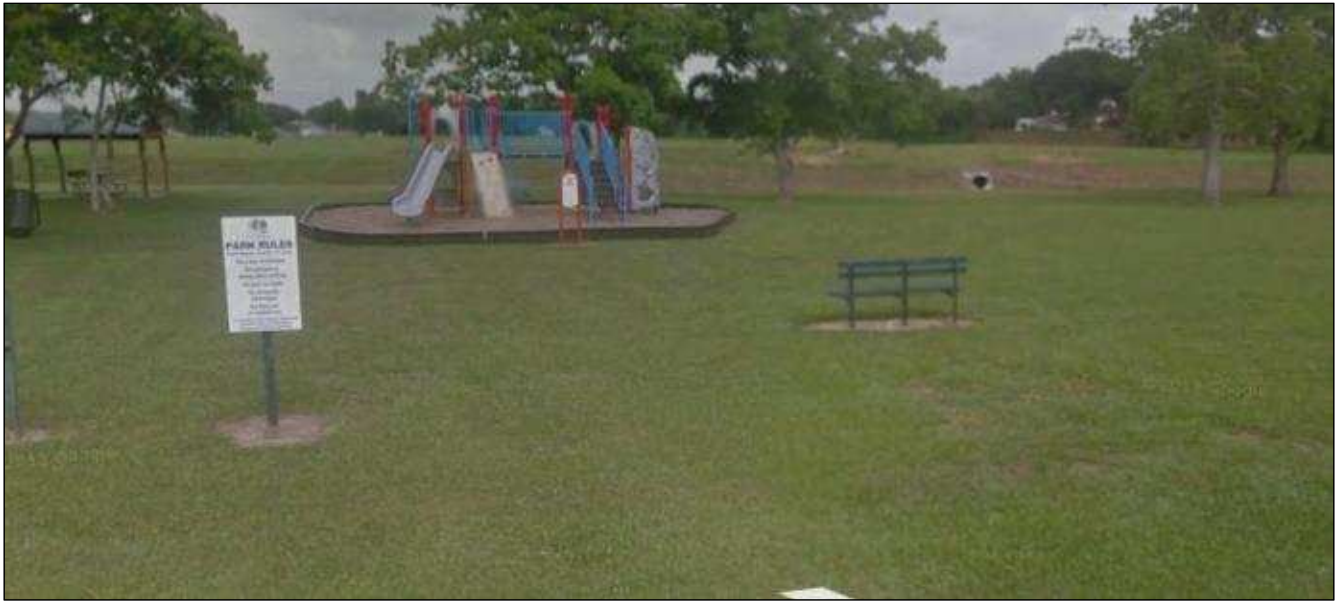
Barrier: 2

Playground: Equipment

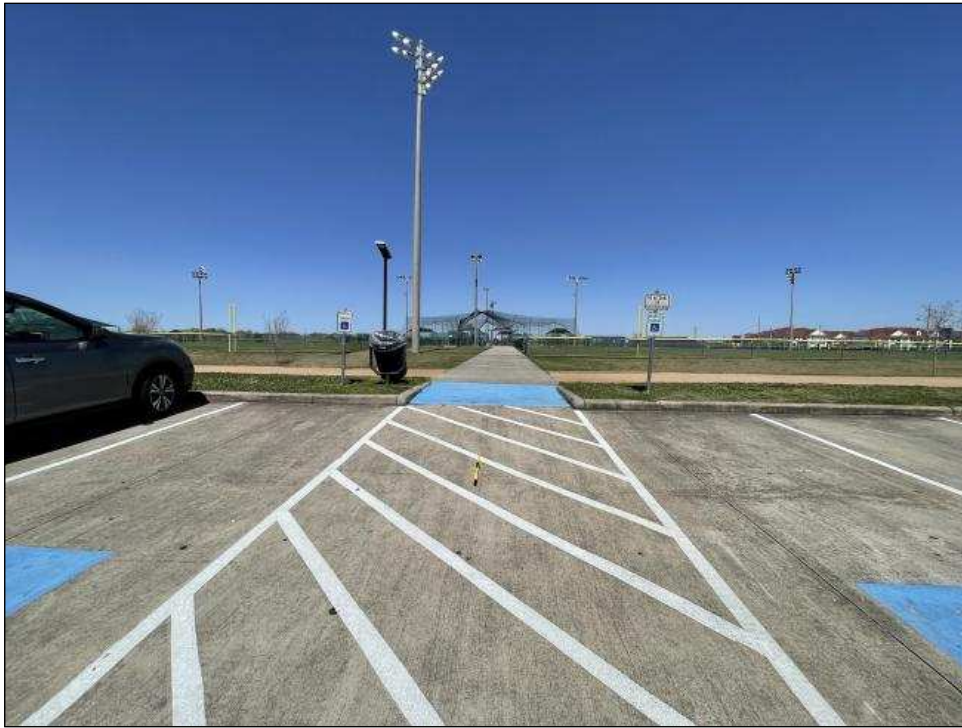
Barrier: 4

Parking Lots: Baseball Fields and Playground Parking

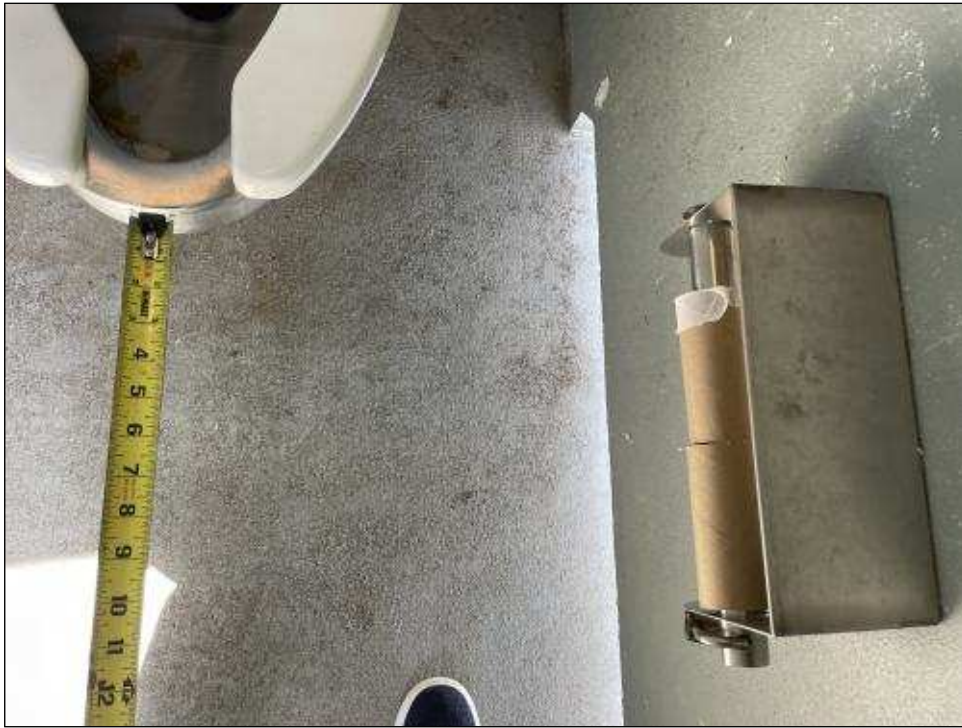
Barrier: 8

Path of Travel: Pavillion

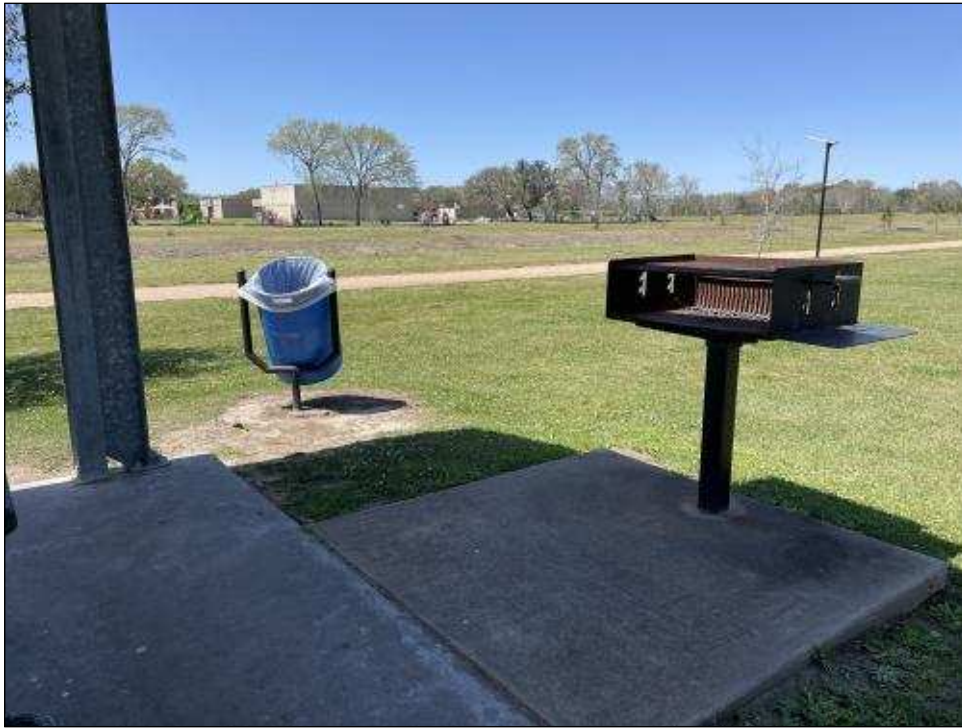
Barrier: 11

Path of Travel: Pavillion

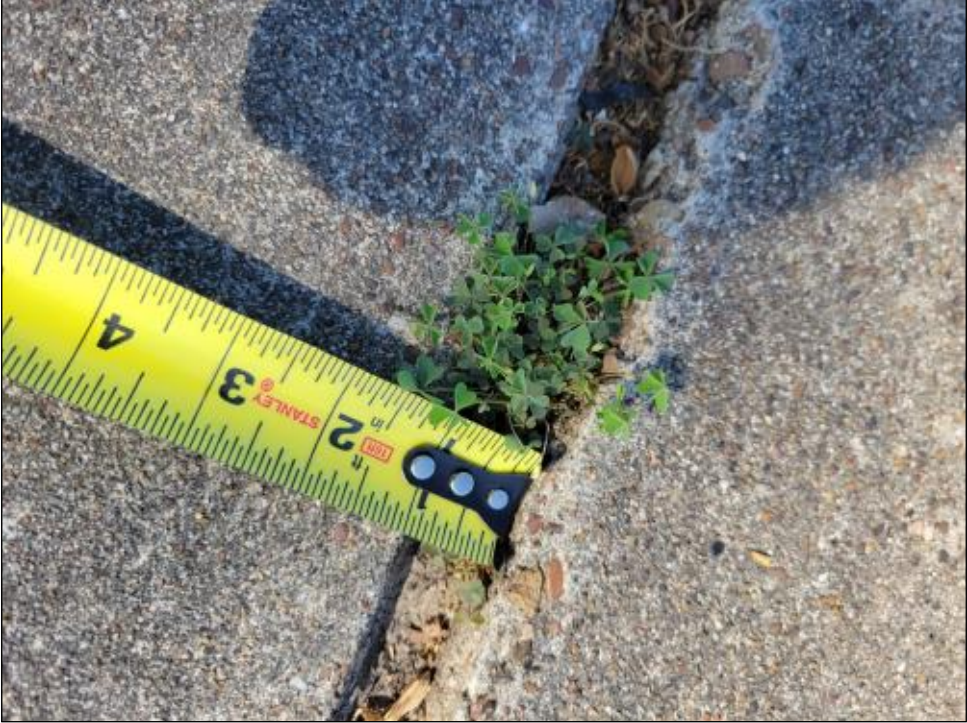
Barrier: 8

Accessible Route: Accessible Route

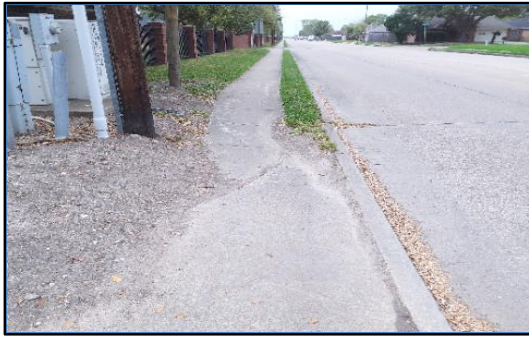
Ramp 1A

Turning space running slope is greater than 2%			
Turning space cross slope greater than 2%	X	X	
Temporary obstruction (>0.25') in curb ramp/landing/flares			
Non-compliant detectable warning surface (DWS)			
No detectable warning surface (DWS)			
Curb ramp transition onto roadway is greater than 0.25'	X		Fix curb ramp transition
Counter slope of the gutter or street at the foot of the curb ramp is greater than 5%			
Ponding occurs at base of curb ramp	X	X	Fix ponding

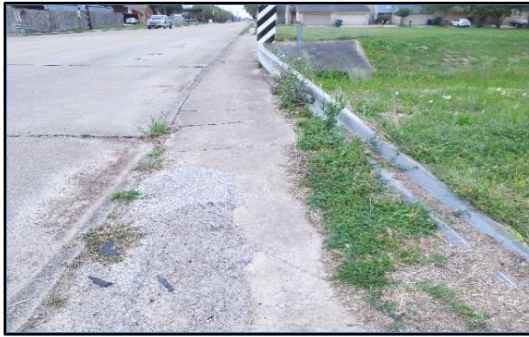
Ramp 2A

Turning space running slope is greater than 2%	X		
Turning space cross slope greater than 2%		X	
Temporary obstruction (>0.25') in curb ramp/landing/flares			
Non-compliant detectable warning surface (DWS)			
No detectable warning surface (DWS)			
Curb ramp transition onto roadway is greater than 0.25"	X	X	Fix curb ramp transition
Counter slope of the gutter or street at the foot of the curb ramp is greater than 5%			
Ponding occurs at base of curb ramp	X	X	Fix ponding
