City of Angleton, Texas

Americans with Disabilities Act (ADA) Self-Evaluation & Transition Plan

September 2022

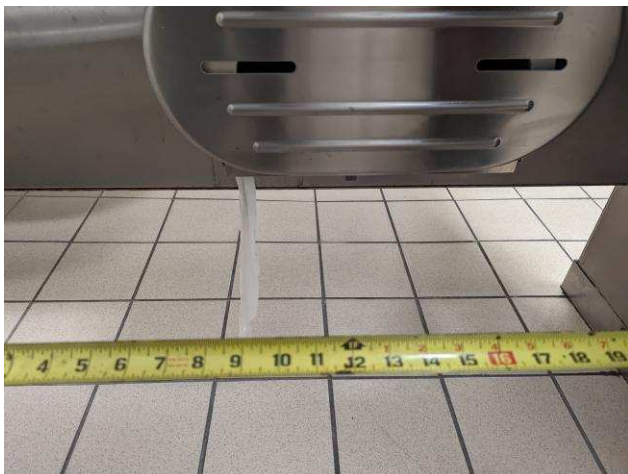
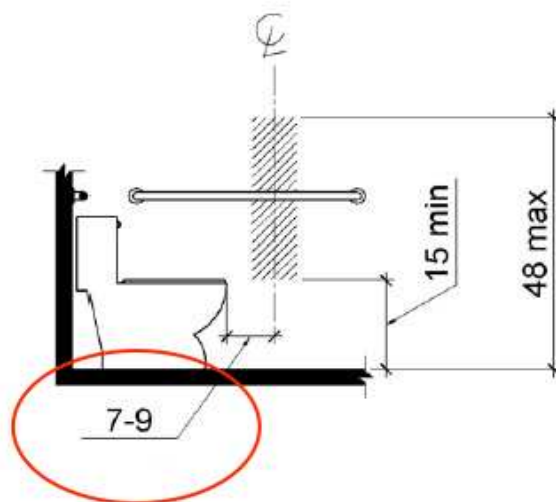
Barrier: 10

Restrooms: Family Restroom

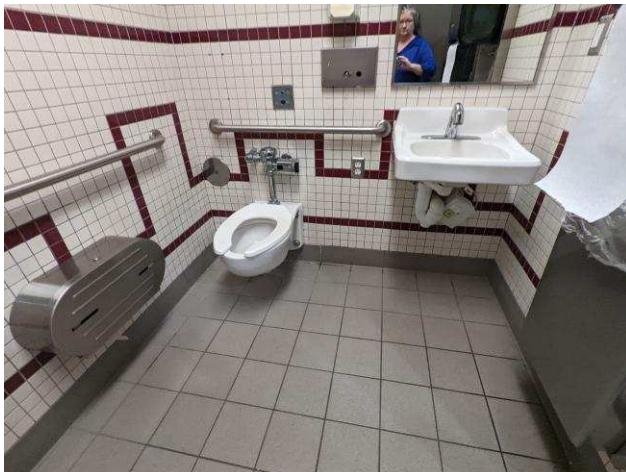
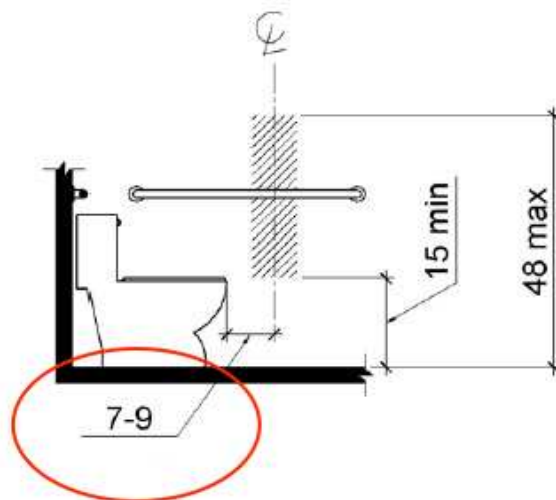
Barrier: 11

Restrooms: Women's Locker Rooms

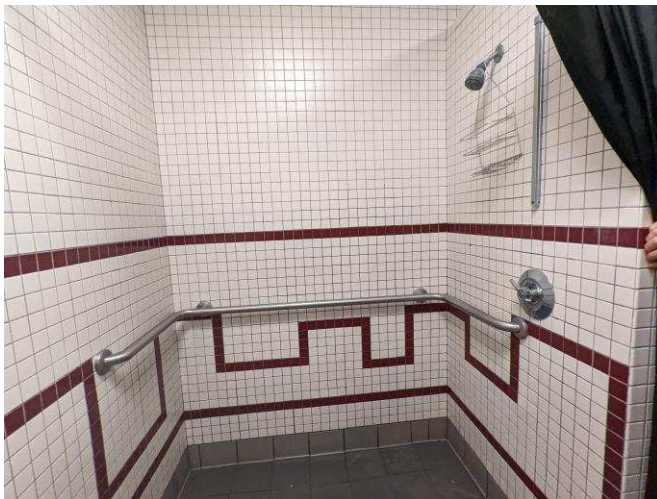
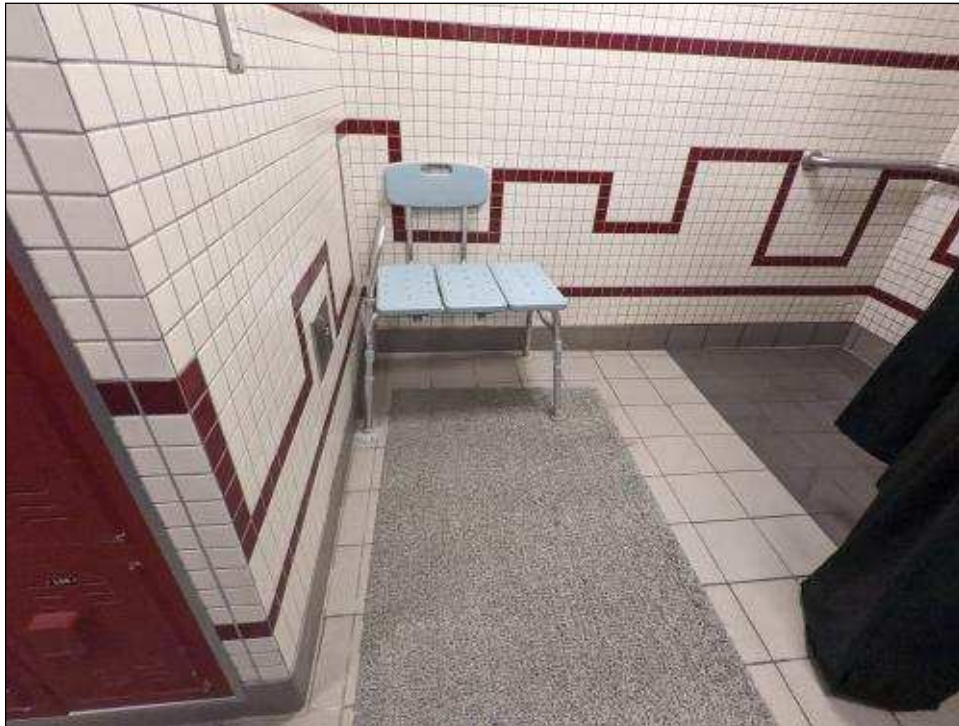
Barrier #11 Additional Barrier Photos

Restrooms: Women's Locker Rooms

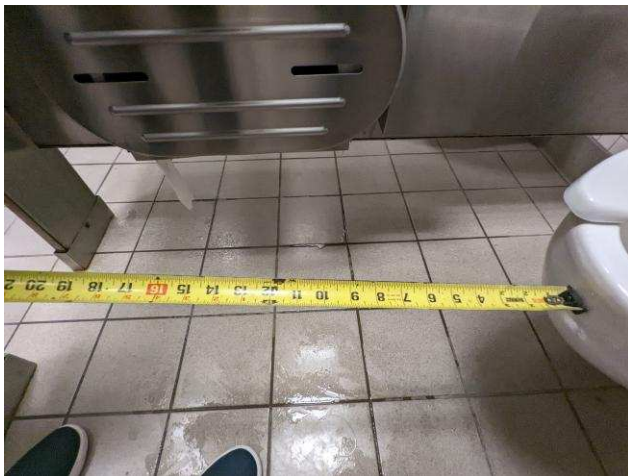
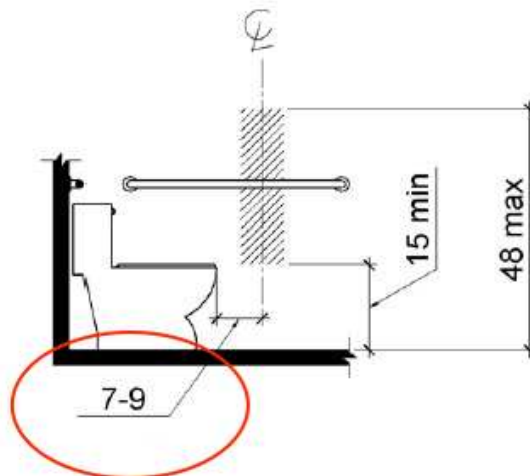
Barrier: 13

Restrooms: Women's Locker Rooms

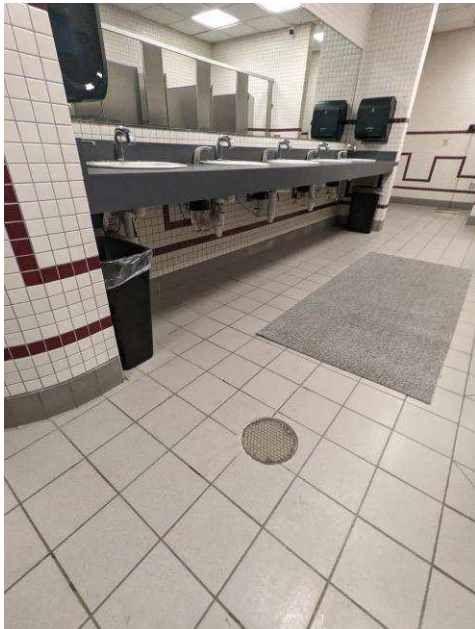
Barrier: 14

Restrooms: Women's Locker Rooms

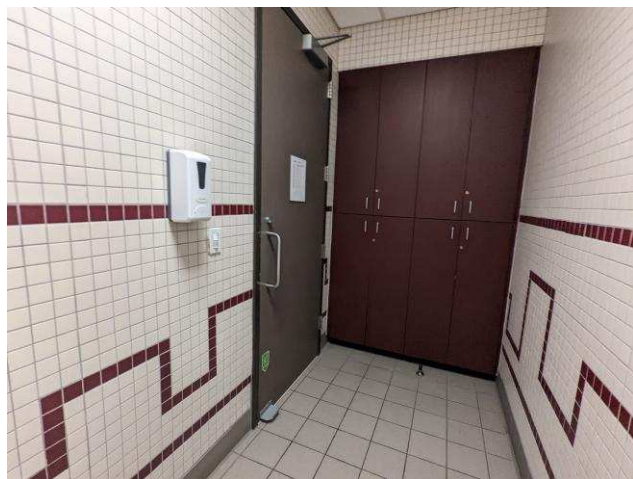
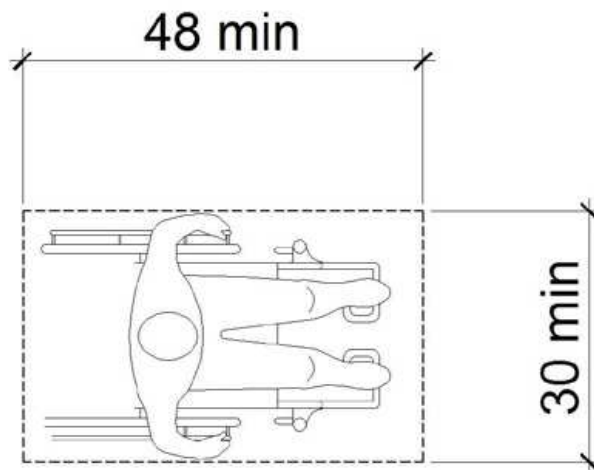
Barrier: 15

Restrooms: Men's Locker Rooms

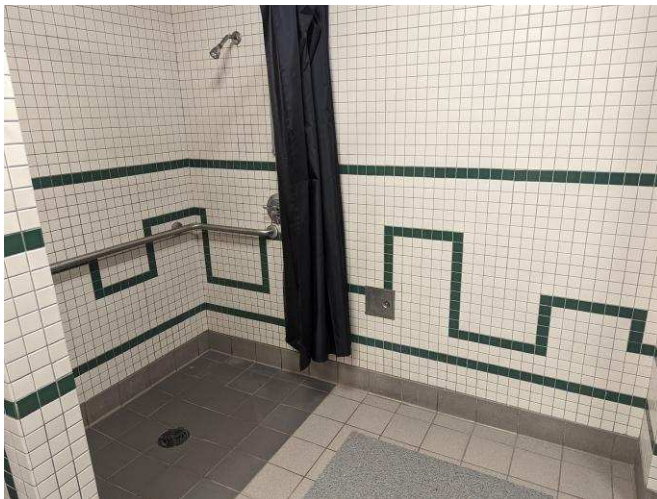
Barrier: 16

Restrooms: Men's Locker Rooms

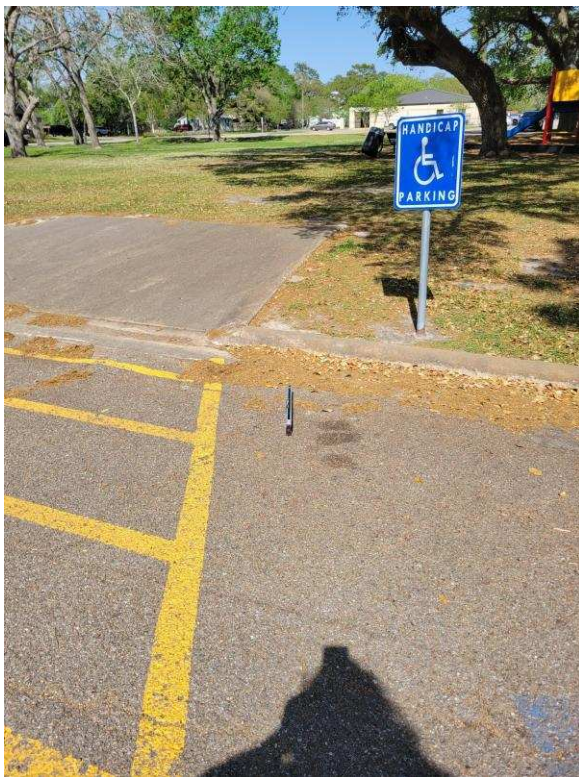
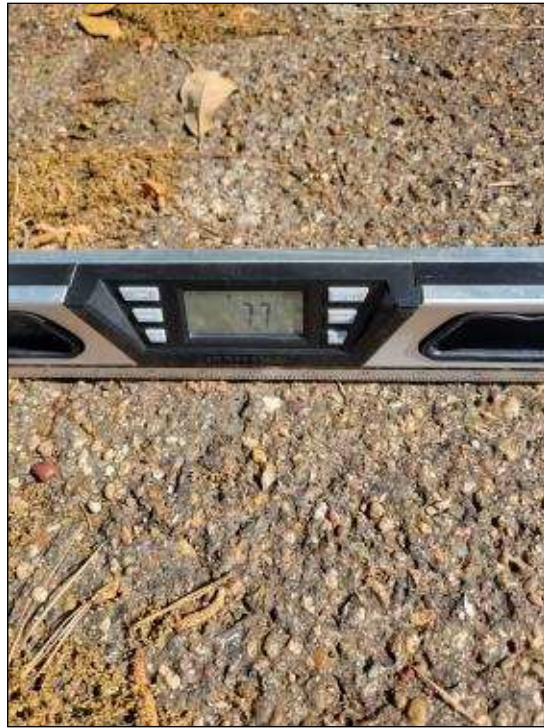
Barrier #1 Additional Barrier Photos

Level 2 (High): Parking and exterior accessible routes (DOJ Level 1) – severely out of compliance; near a hospital, school, transit stop, govt. bldg., or other pedestrian attractor

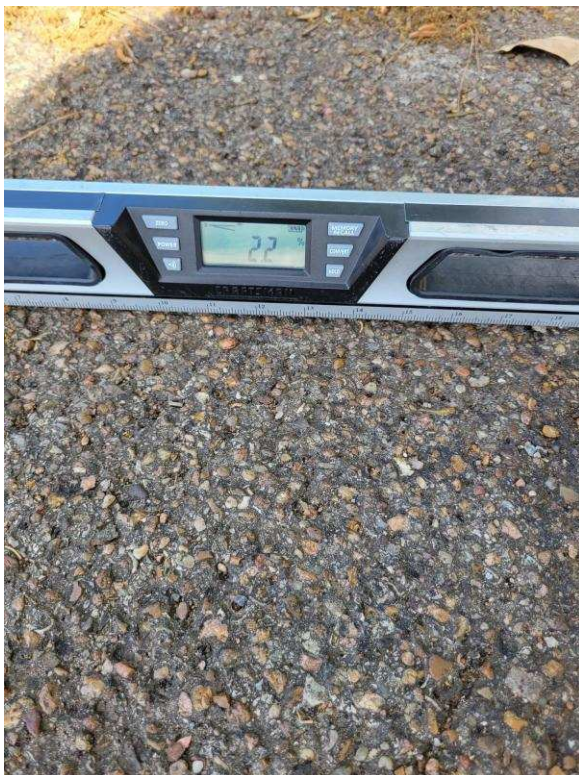
Barrier: 2

Level 2 (High): Parking and exterior accessible routes (DOJ Level 1) – severely out of compliance; near a hospital, school, transit stop, govt. bldg., or other pedestrian attractor

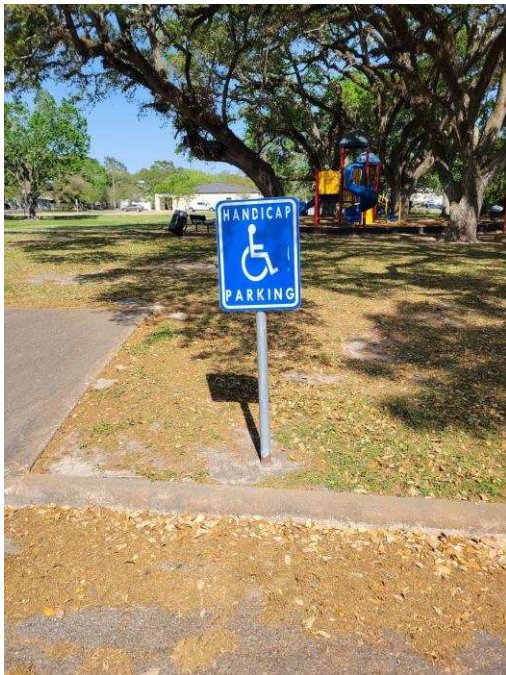
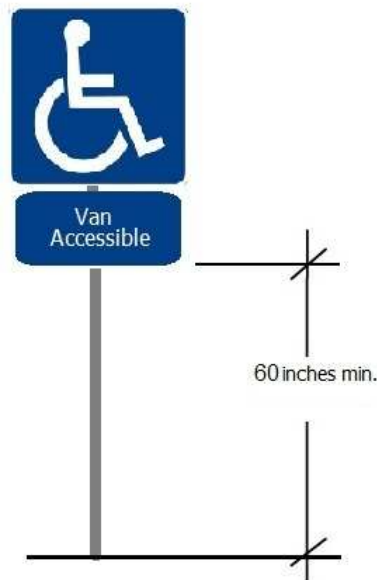
Barrier: 3

Level 6 (Medium): Parking or exterior accessible routes (DOJ Level 1) – minimally out of compliance
Access to goods and services (DOJ Level 2) – moderately out of compliance
Restrooms (DOJ Level 3) – severely out of compliance

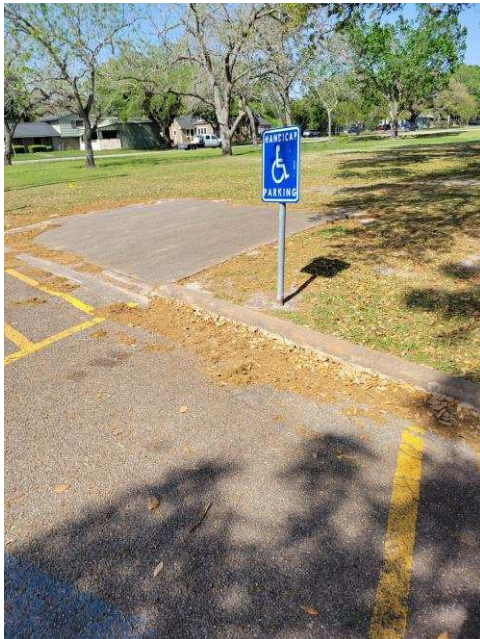
Barrier: 4

Level 2 (High): Parking and exterior accessible routes (DOJ Level 1) – severely out of compliance; near a hospital, school, transit stop, govt. bldg., or other pedestrian attractor

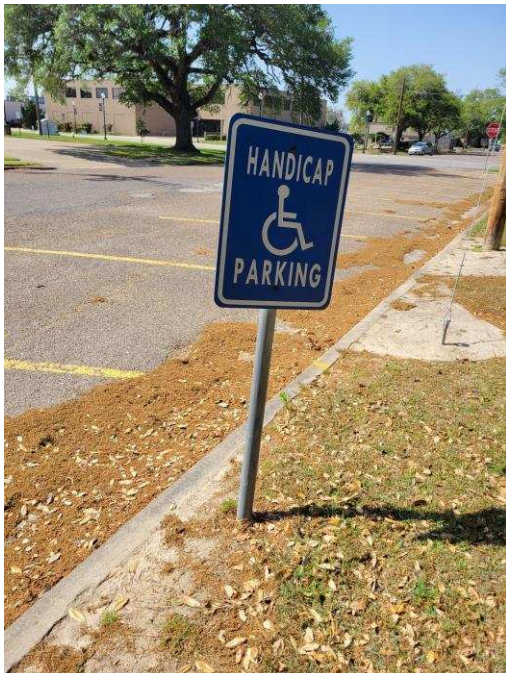
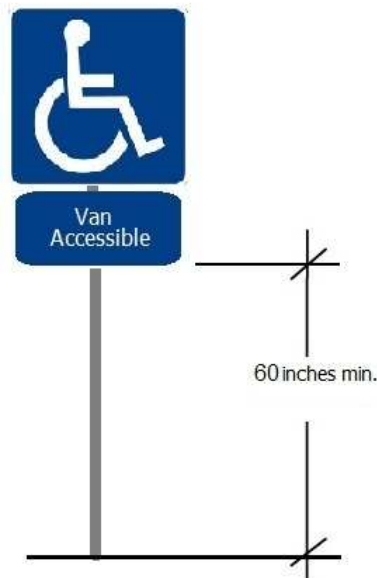
Barrier: 6

Level 6 (Medium): Parking or exterior accessible routes (DOJ Level 1) – minimally out of compliance
Access to goods and services (DOJ Level 2) – moderately out of compliance
Restrooms (DOJ Level 3) – severely out of compliance

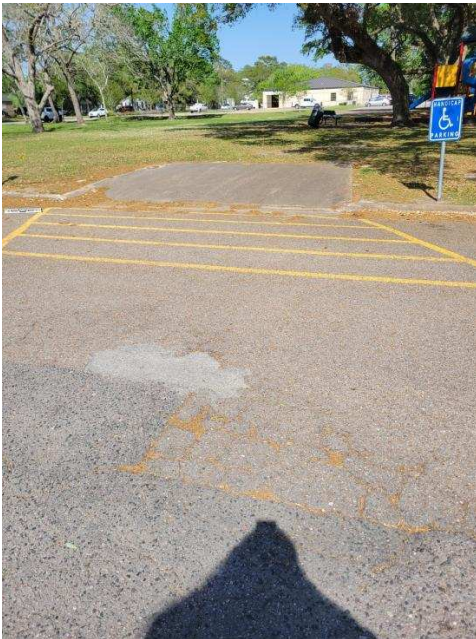
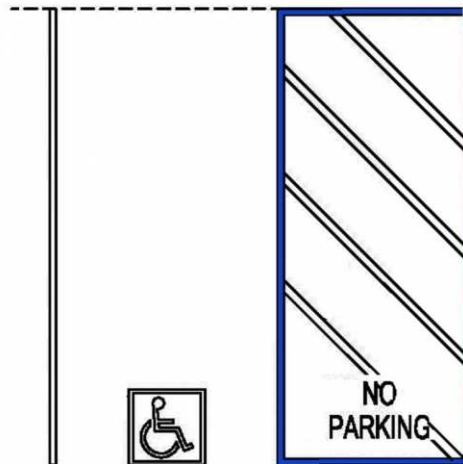
Barrier: 7

The striping for the accessible parking stalls loading/unloading access aisle is missing.

The words "NO PARKING" is missing from the access aisle adjacent to the parking space per Texas Administrative Code.

Level 5 (Medium): Access to goods and services issues (DOJ Level 2) – severely out of compliance

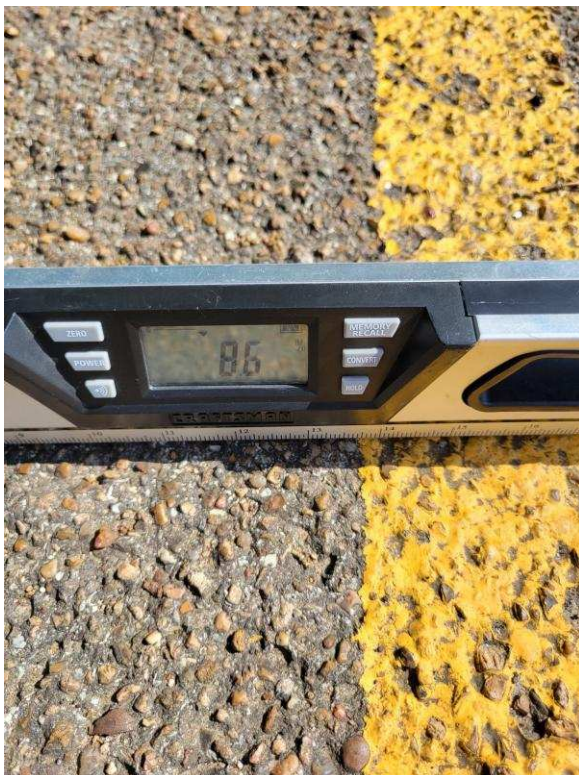
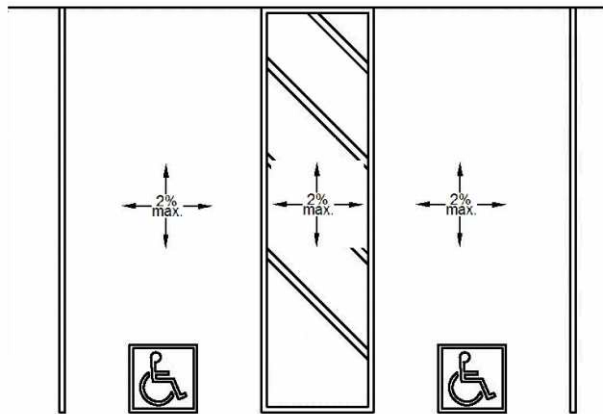
Barrier: 8

Level 2 (High): Parking and exterior accessible routes (DOJ Level 1) – severely out of compliance; near a hospital, school, transit stop, govt. bldg., or other pedestrian attractor

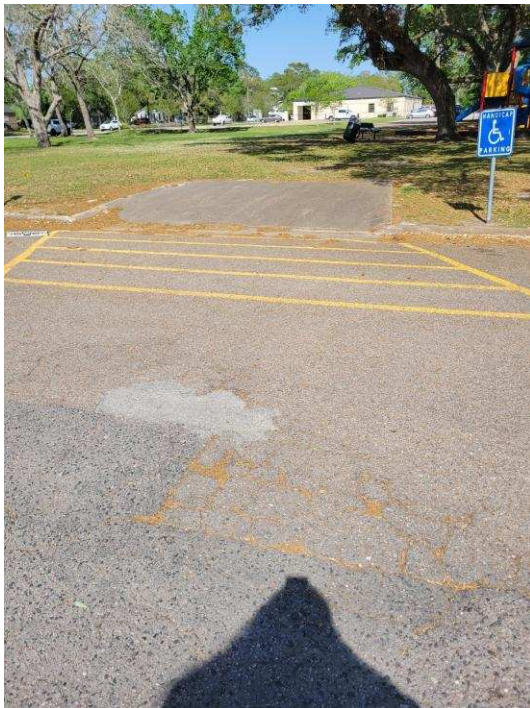
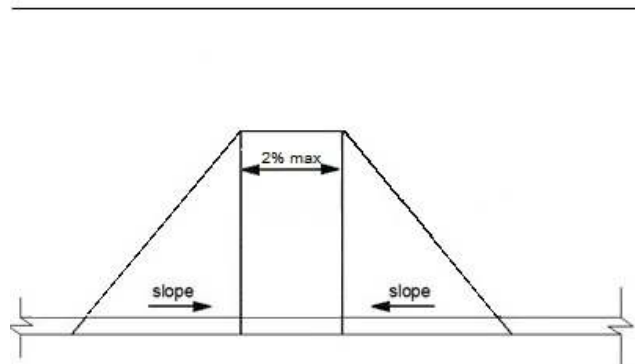
Barrier: 9

Level 2 (High): Parking and exterior accessible routes (DOJ Level 1) – severely out of compliance; near a hospital, school, transit stop, govt. bldg., or other pedestrian attractor

Remove and replace curb ramp.

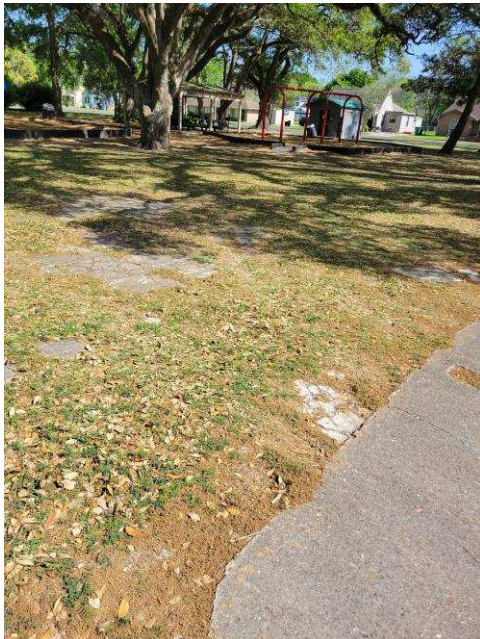
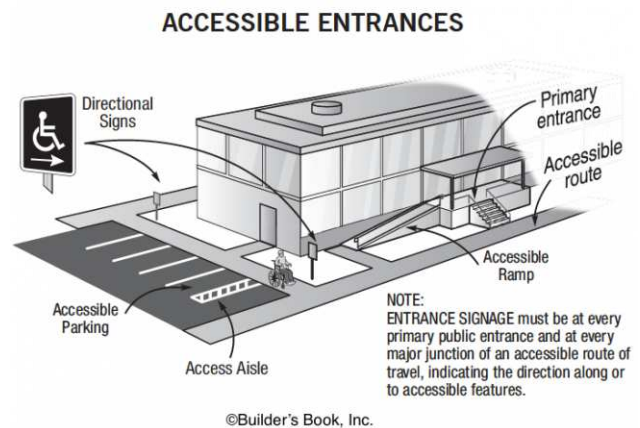
Barrier: 10

Level 6 (Medium): Parking or exterior accessible routes (DOJ Level 1) – minimally out of compliance
Access to goods and services (DOJ Level 2) – moderately out of compliance
Restrooms (DOJ Level 3) – severely out of compliance

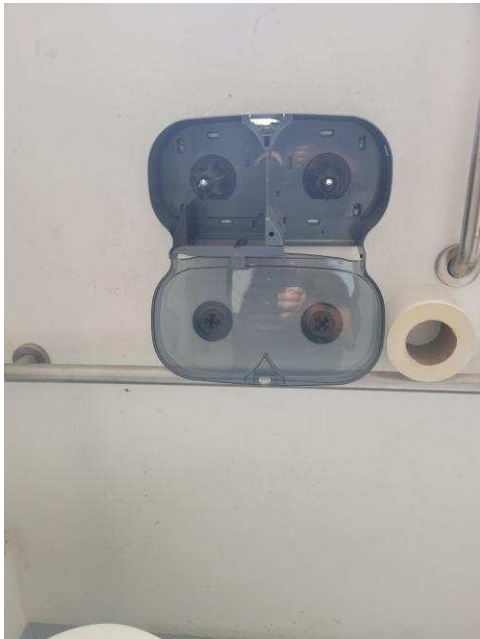
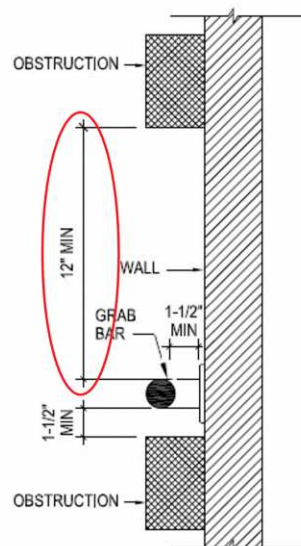
Barrier: 12

Level 9 (Low): Restrooms (DOJ Level 3) – minimally out of compliance

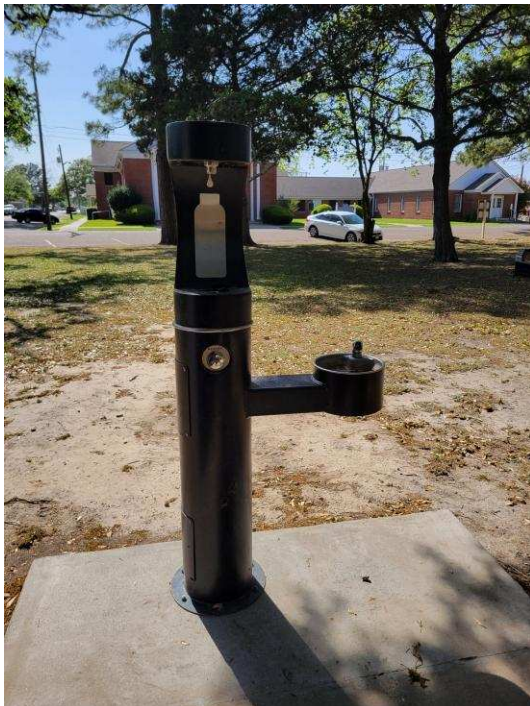
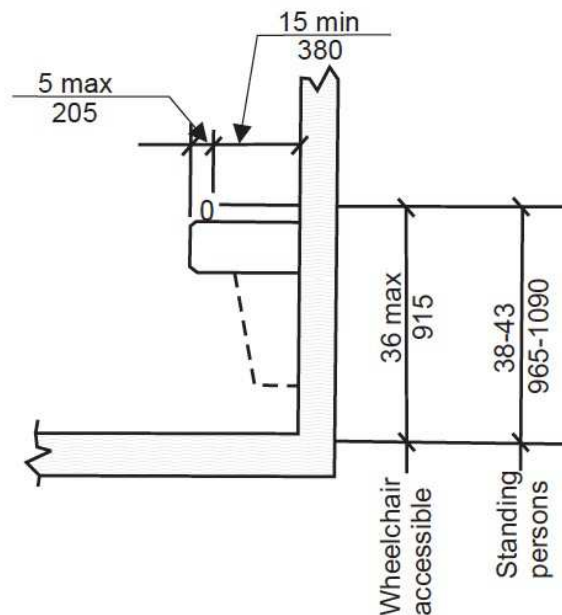
Barrier: 13

Level 7 (Medium): Access to goods and services (DOJ Level 2) – minimally out of compliance
Restrooms (DOJ Level 3) – moderately out of compliance
Drinking fountains and public phones (DOJ Level 4 & 5) – severely out of compliance

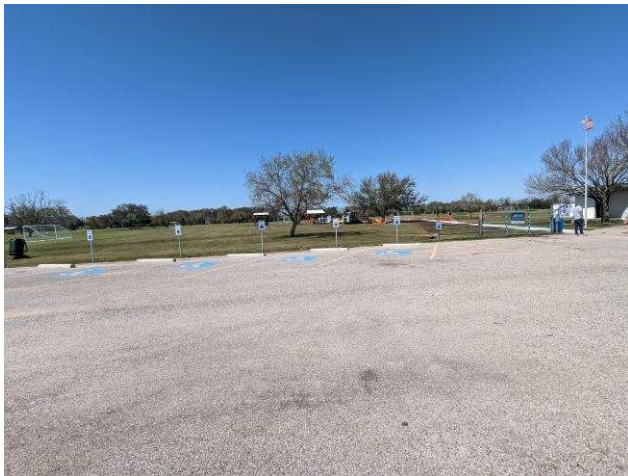
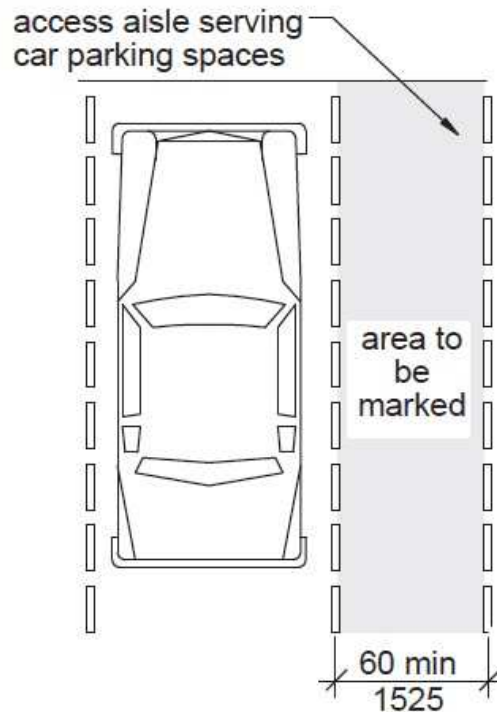
The access aisle is missing at the majority of the accessible parking stalls.

Level 3 (High): Parking and exterior accessible routes (DOJ Level 1) – severely out of compliance; NOT near a hospital, school, transit stop, govt. bldg., or other pedestrian attractor

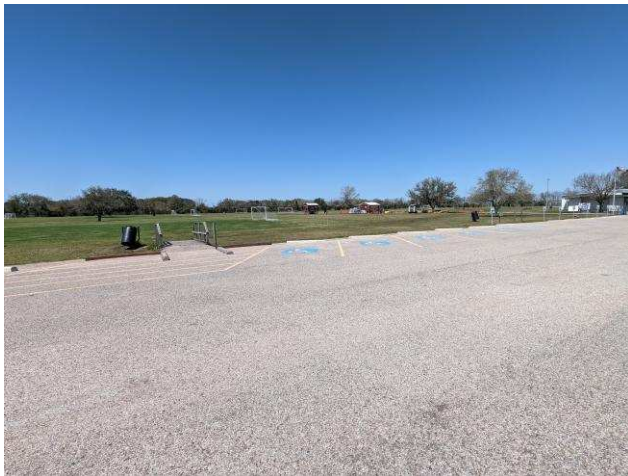
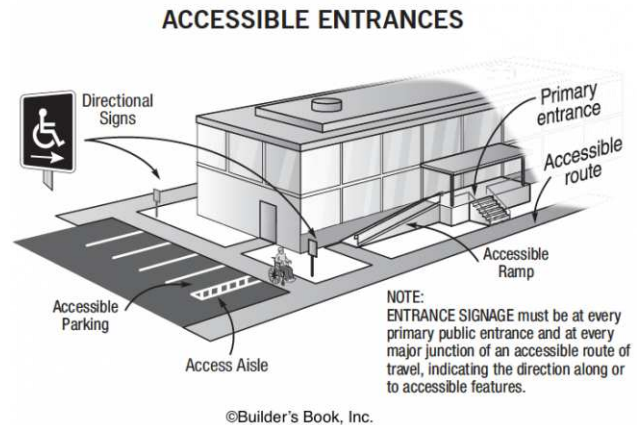
Barrier: 2

Level 3 (High): Parking and exterior accessible routes (DOJ Level 1) – severely out of compliance; NOT near a hospital, school, transit stop, govt. bldg., or other pedestrian attractor

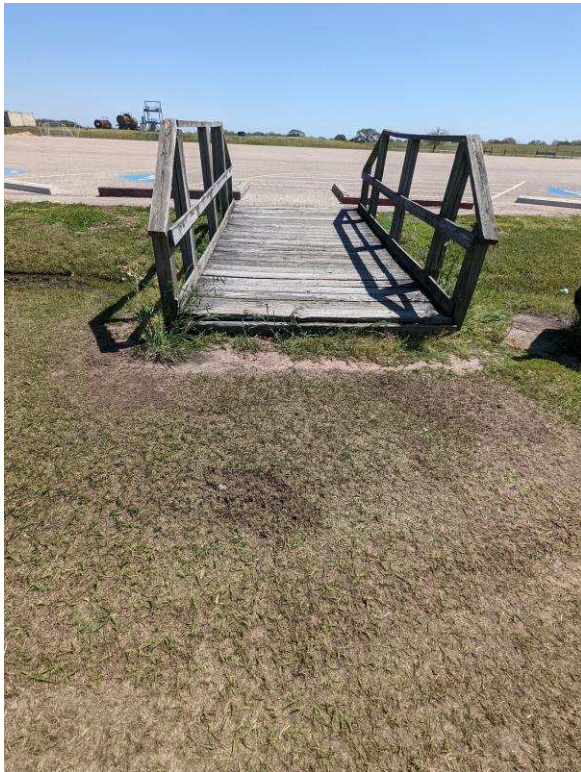
Barrier: 3

Level 5 (Medium): Access to goods and services issues (DOJ Level 2) – severely out of compliance

Replace the pedestrian bridge with a fully compliant accessible route.

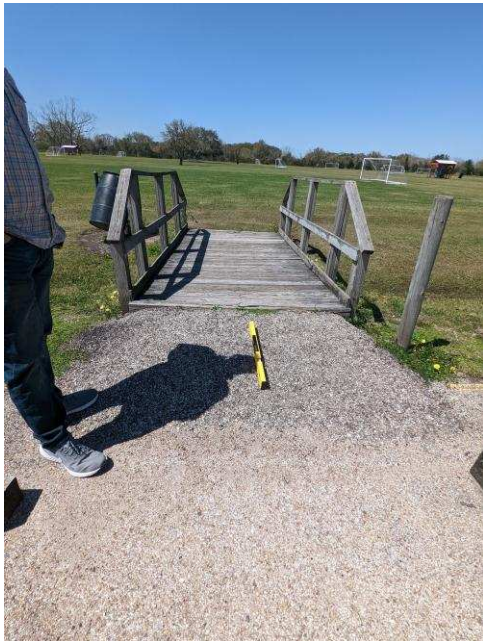
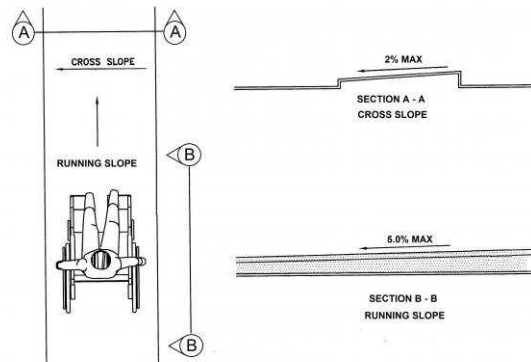
Barrier: 4

Level 4 (High): Parking and exterior accessible routes (DOJ Level 1) – moderately out of compliance

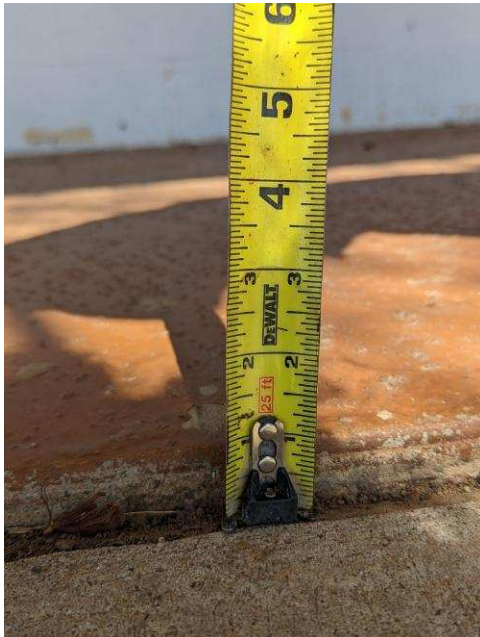
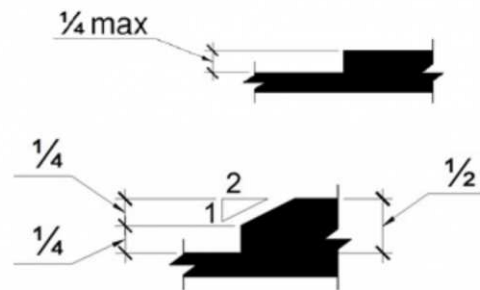
Level 6 (Medium): Parking or exterior accessible routes (DOJ Level 1) – minimally out of compliance
Access to goods and services (DOJ Level 2) – moderately out of compliance
Restrooms (DOJ Level 3) – severely out of compliance

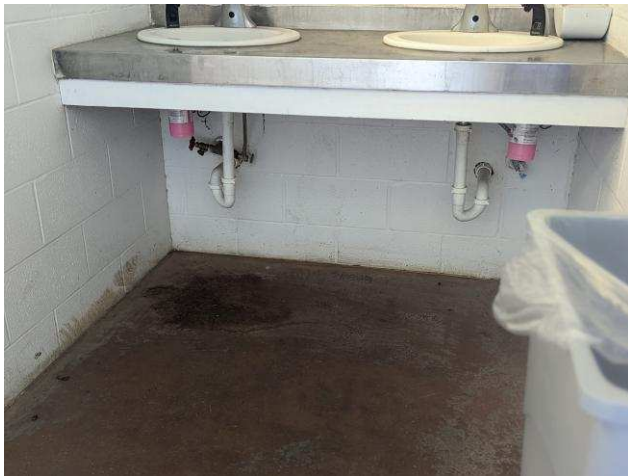
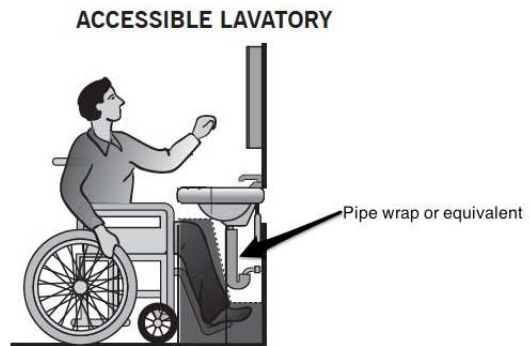
Barrier: 7

Level 8 (Medium): Drinking fountains and public phones (DOJ Level 4 & 5) – moderately out of compliance

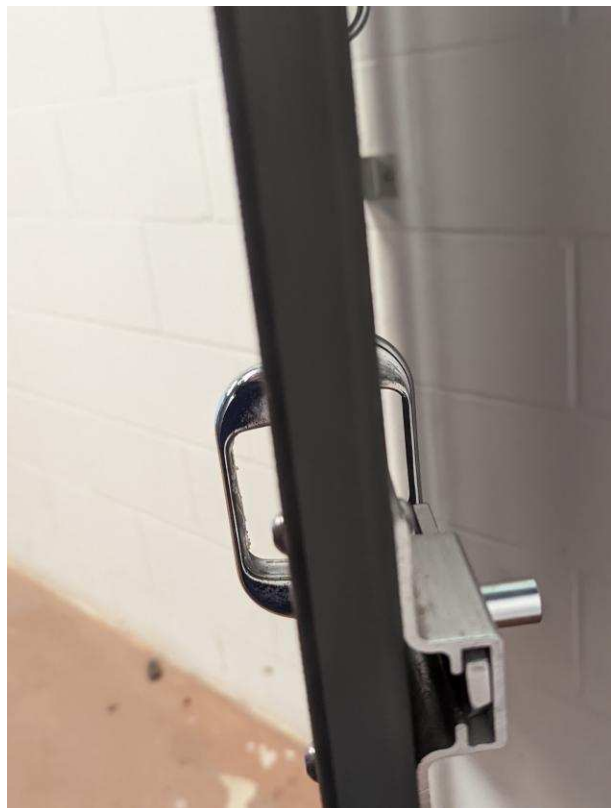
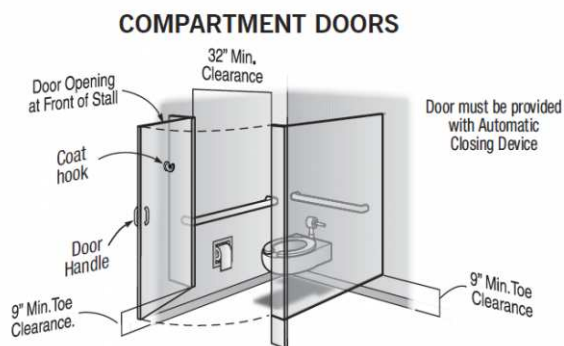
Barrier: 8

Level 9 (Low): Restrooms (DOJ Level 3) – minimally out of compliance

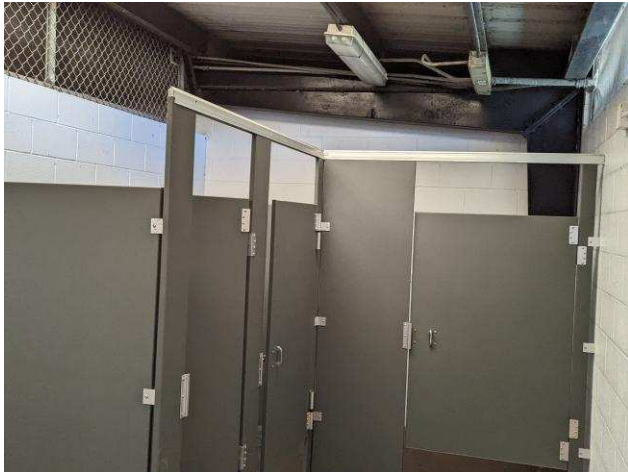
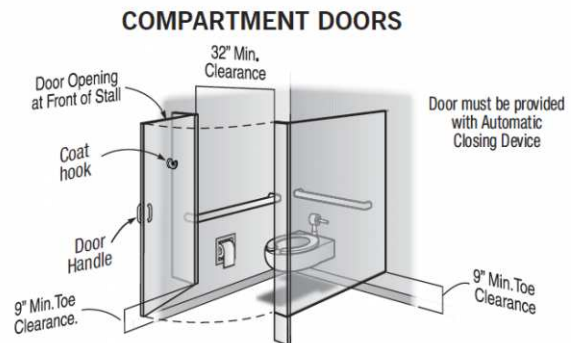
Barrier: 9

Level 9 (Low): Restrooms (DOJ Level 3) – minimally out of compliance

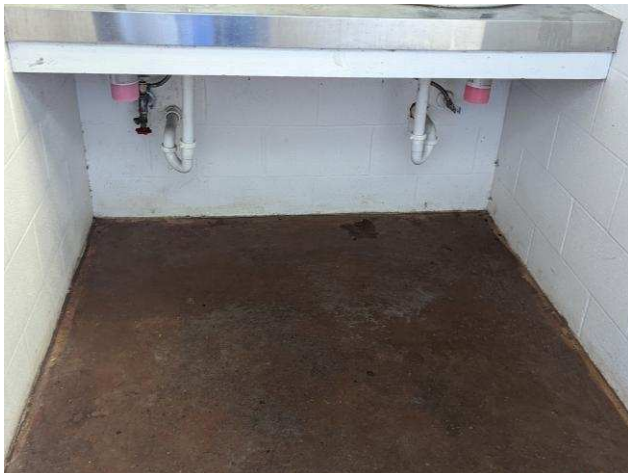
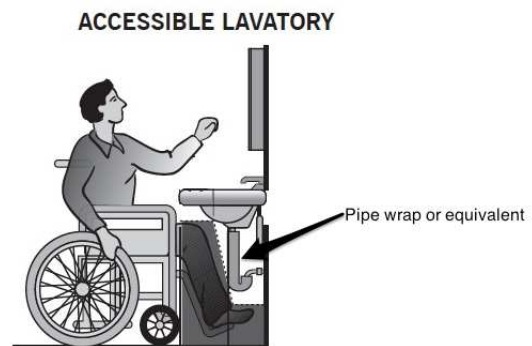
Barrier: 10

Level 8 (Medium): Drinking fountains and public phones (DOJ Level 4 & 5) – moderately out of compliance

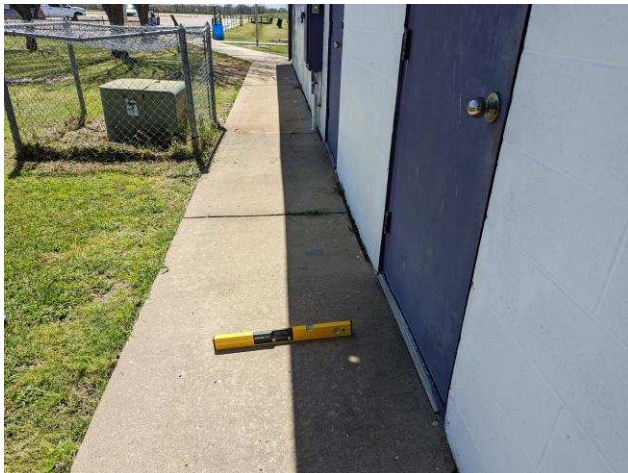
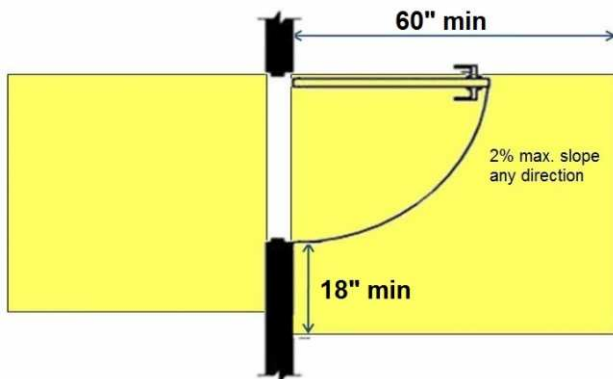
Barrier: 11

Level 6 (Medium): Parking or exterior accessible routes (DOJ Level 1) – minimally out of compliance
Access to goods and services (DOJ Level 2) – moderately out of compliance
Restrooms (DOJ Level 3) – severely out of compliance

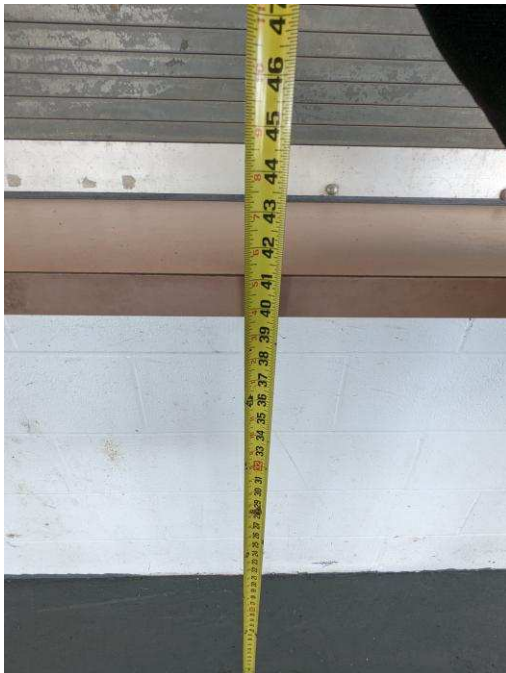
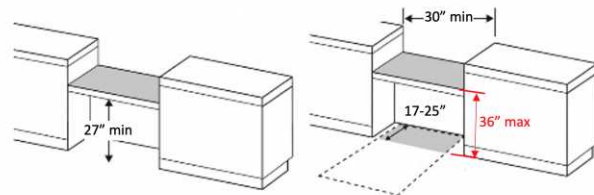
Barrier: 12

Restrooms (DOJ Level 3) – moderately out of compliance

Drinking fountains and public phones (DOJ Level 4 & 5) – severely out of compliance

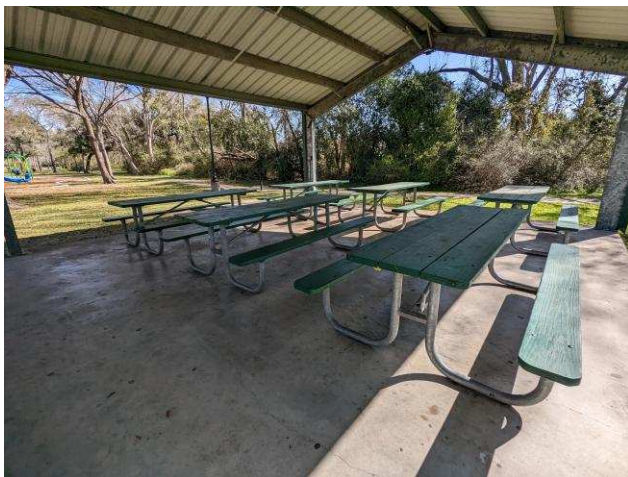
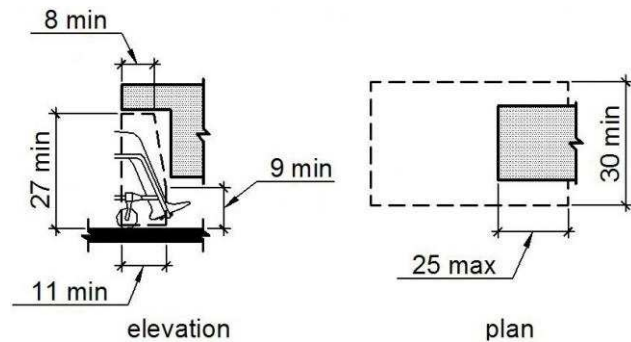
Level 5 (Medium): Access to goods and services issues (DOJ Level 2) – severely out of compliance

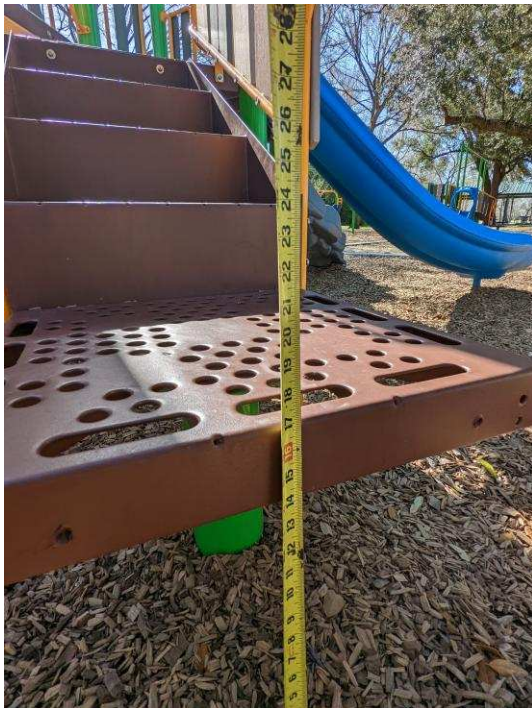
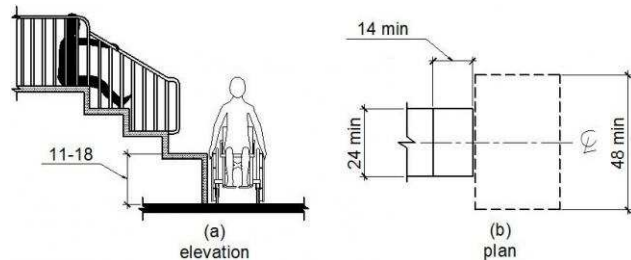
Barrier: 2

Transfer support missing.

Access to goods and services (DOJ Level 2) – moderately out of compliance

Restrooms (DOJ Level 3) – severely out of compliance

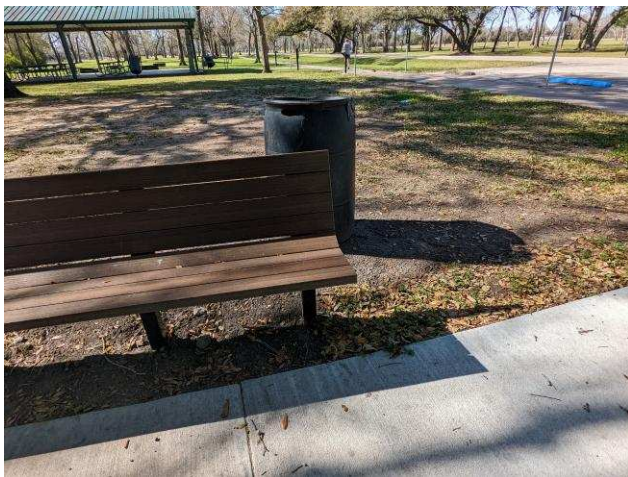
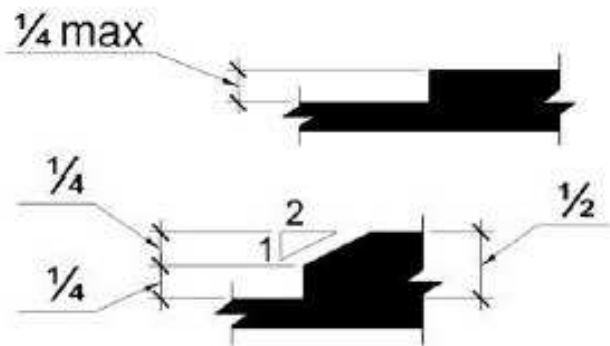
Barrier: 3

Level 6 (Medium): Parking or exterior accessible routes (DOJ Level 1) – minimally out of compliance
Access to goods and services (DOJ Level 2) – moderately out of compliance
Restrooms (DOJ Level 3) – severely out of compliance

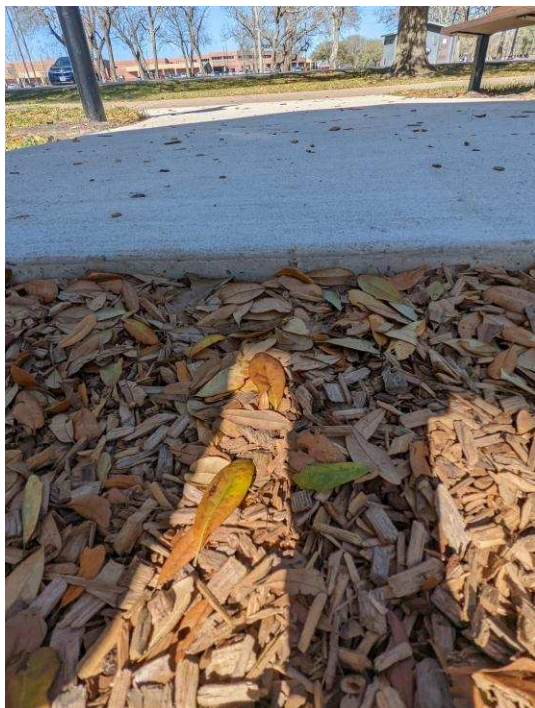
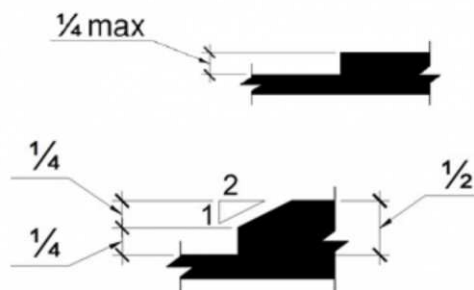
Barrier: 4

Level 5 (Medium): Access to goods and services issues (DOJ Level 2) – severely out of compliance

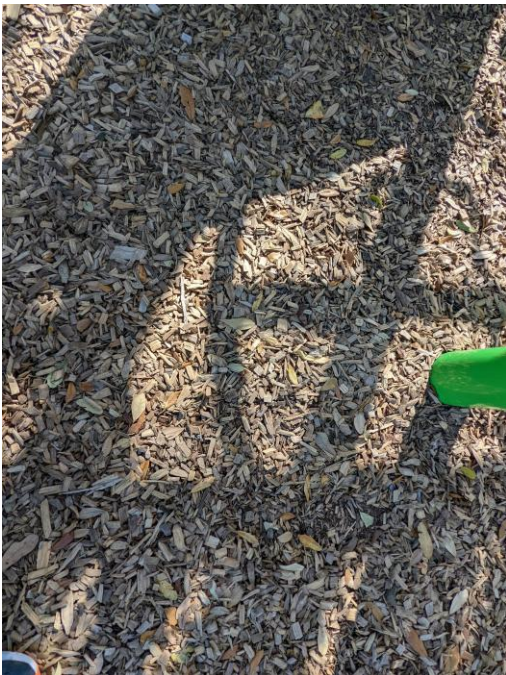
Barrier: 5

Level 8 (Medium): Drinking fountains and public phones (DOJ Level 4 & 5) – moderately out of compliance

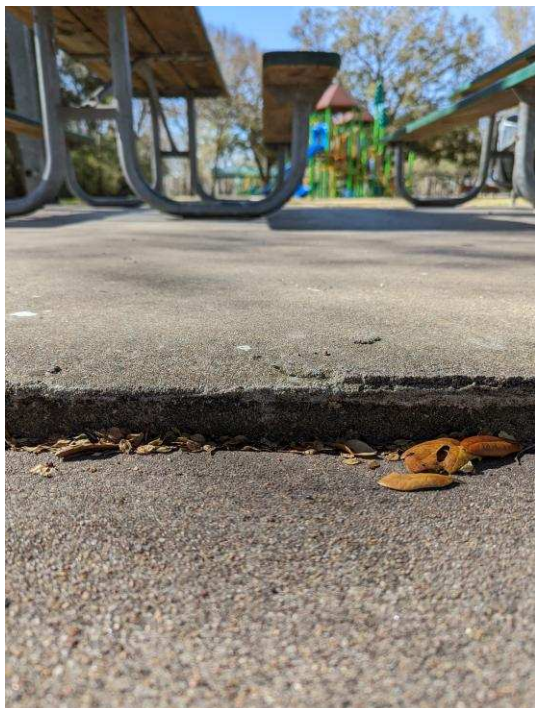
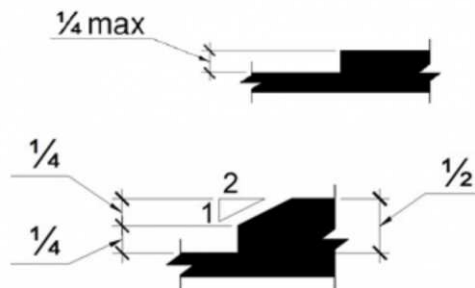
Barrier: 6

Level 5 (Medium): Access to goods and services issues (DOJ Level 2) – severely out of compliance

Repair ground surface to provide a smooth transition to the grill.

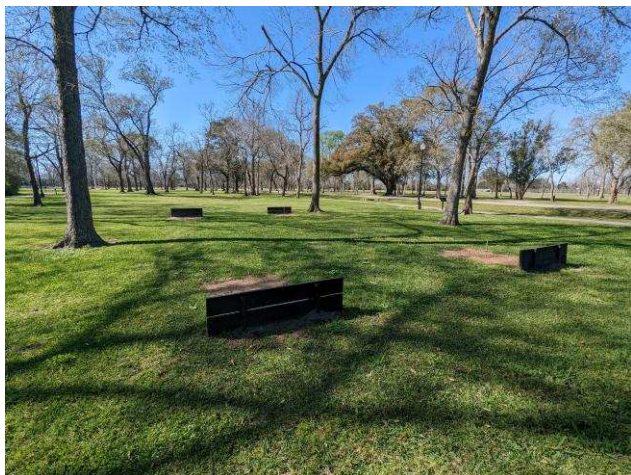
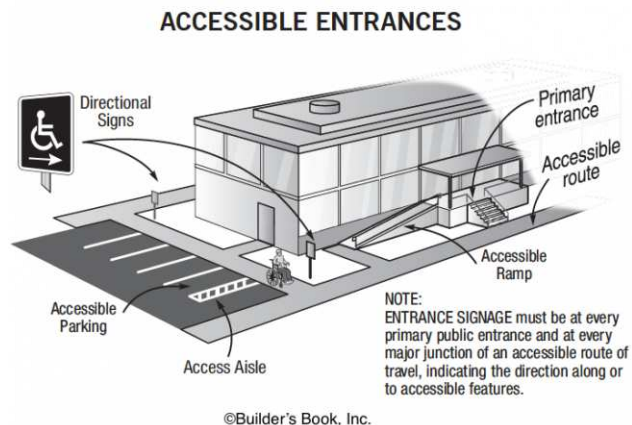
Barrier: 7

Level 5 (Medium): Access to goods and services issues (DOJ Level 2) – severely out of compliance

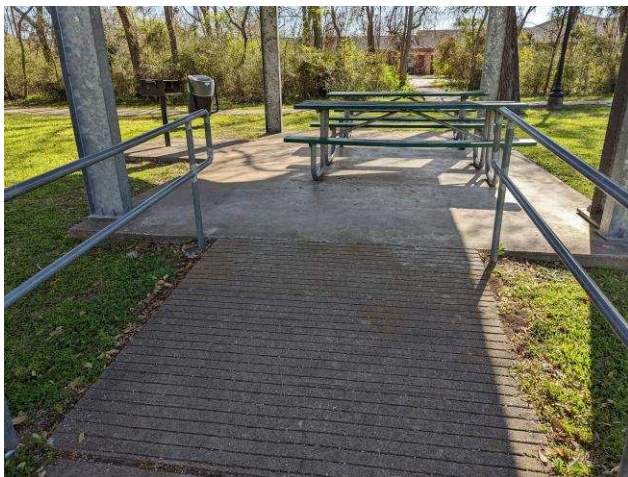
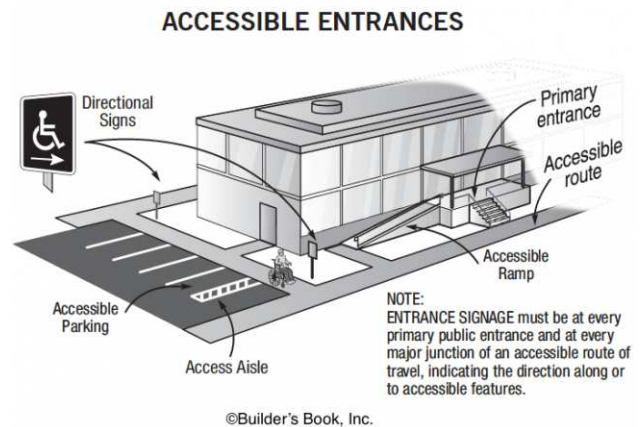
Barrier: 8

Access to goods and services (DOJ Level 2) – moderately out of compliance

Restrooms (DOJ Level 3) – severely out of compliance

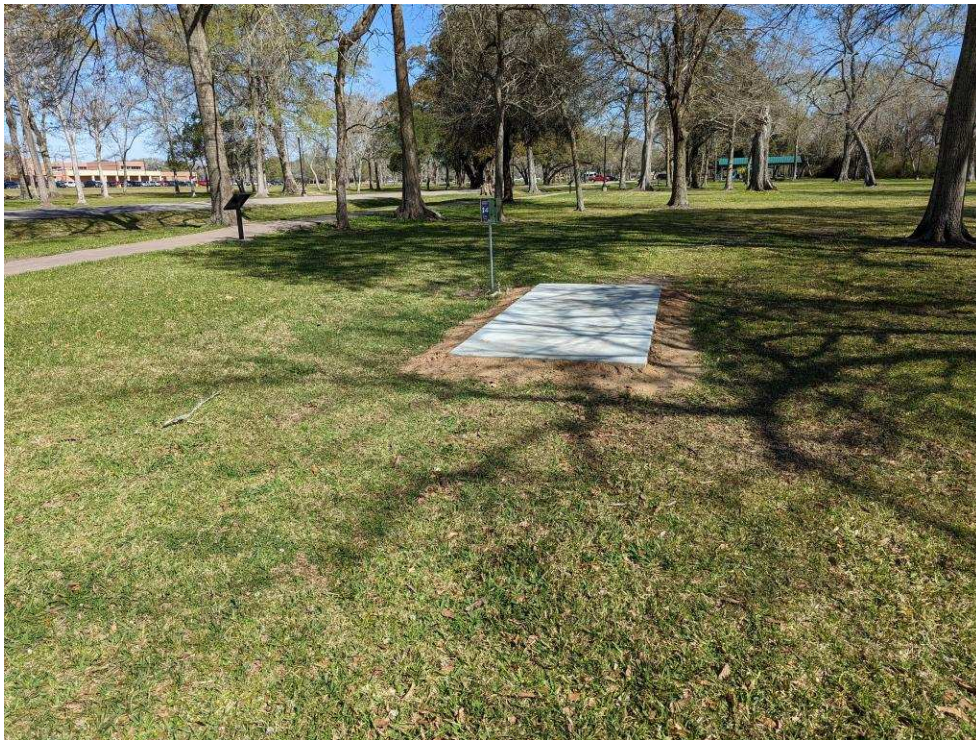
Level 6 (Medium): Parking or exterior accessible routes (DOJ Level 1) – minimally out of compliance
Access to goods and services (DOJ Level 2) – moderately out of compliance
Restrooms (DOJ Level 3) – severely out of compliance

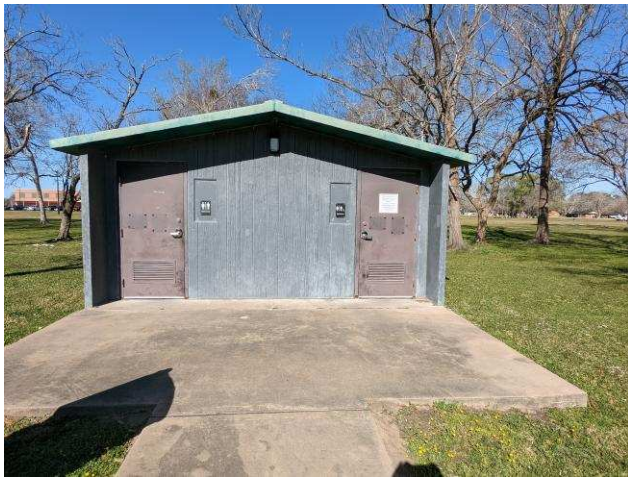
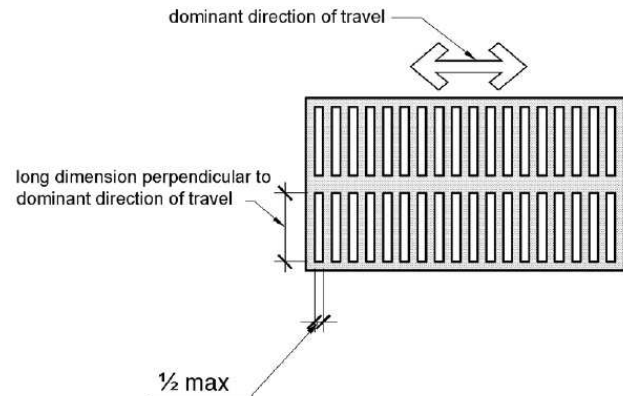
Barrier: 10

Level 6 (Medium): Parking or exterior accessible routes (DOJ Level 1) – minimally out of compliance
Access to goods and services (DOJ Level 2) – moderately out of compliance
Restrooms (DOJ Level 3) – severely out of compliance
