City of Angleton, Texas

Americans with Disabilities Act (ADA) Self-Evaluation & Transition Plan

September 2022

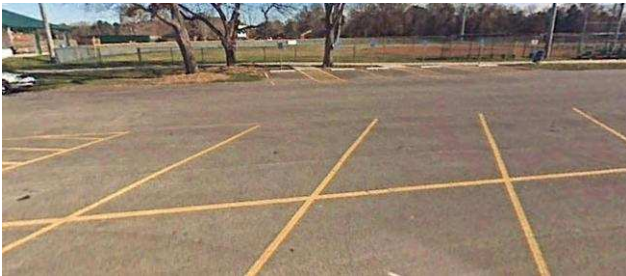
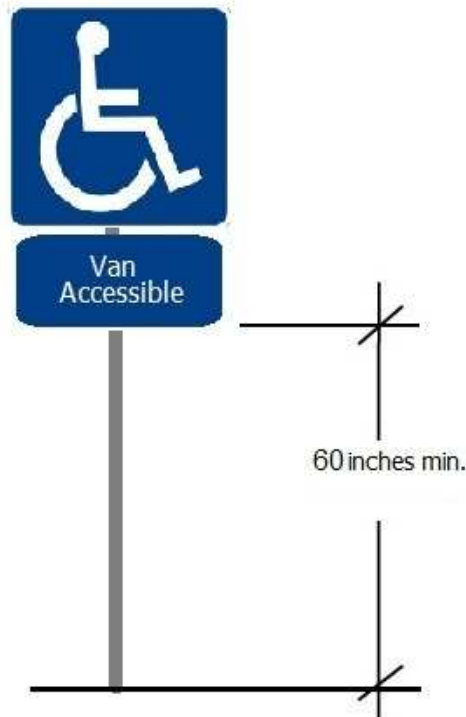
Barrier: 2

Pavillion: Accessible Route

Provide a level, stable and slip resistant ground surface route to each amenity throughout the park. Also add a wheel stop to protect the clear floor space.

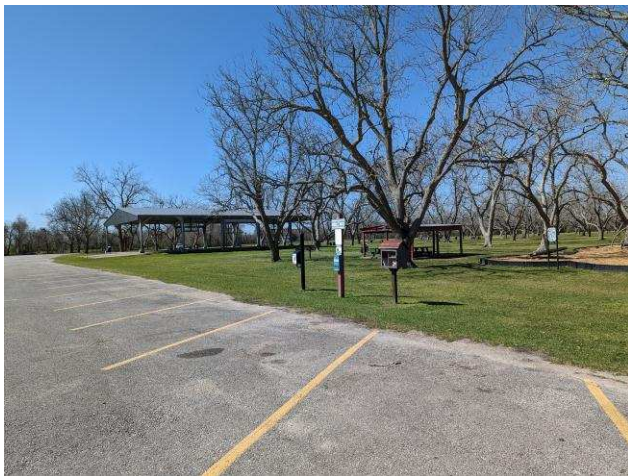
Barrier: 3

Pavillion: Accessible Route

Provide a firm, stable and slip-resistant connection to the pavilion and picnic tables.

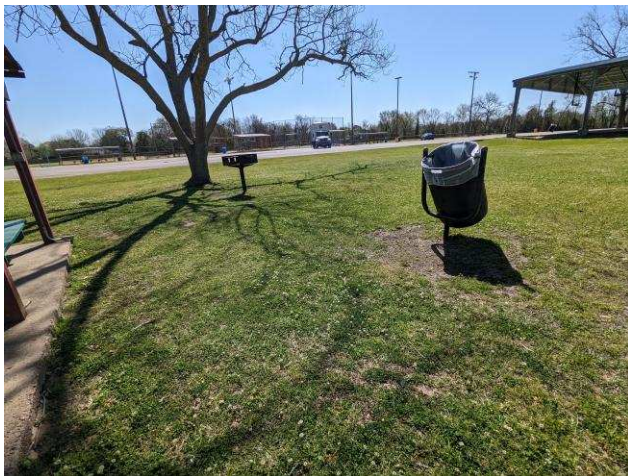
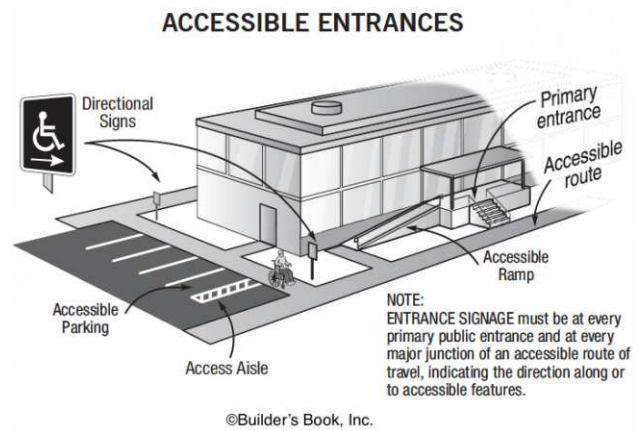
Barrier: 6

Pavillion: Accessible Route

Modify ramps to obtain no greater than 8.33% running slope with handrails on both sides.

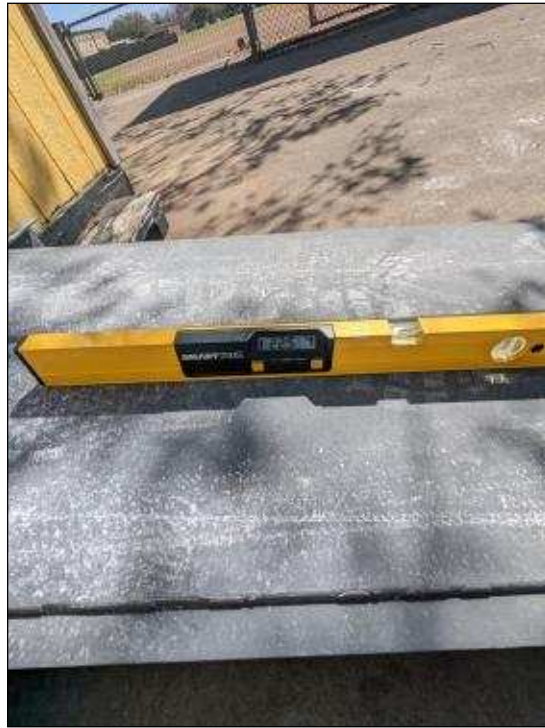
Barrier: 12

Concession Stand: Access

Grate drain is set too low which causes a slope over 2%

Replace the plaza area between the fields to ensure the slope does not exceed 2% in any direction.

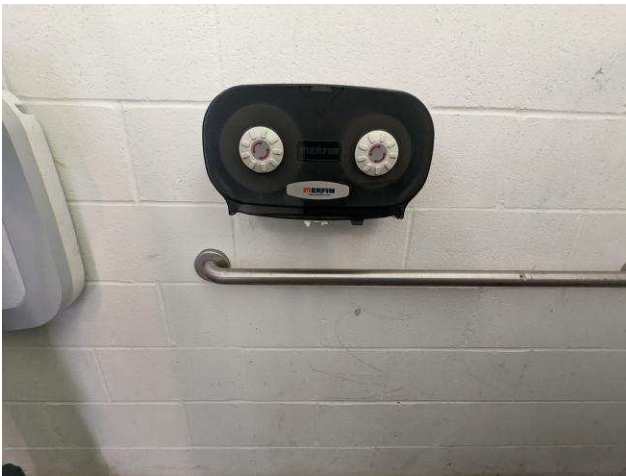
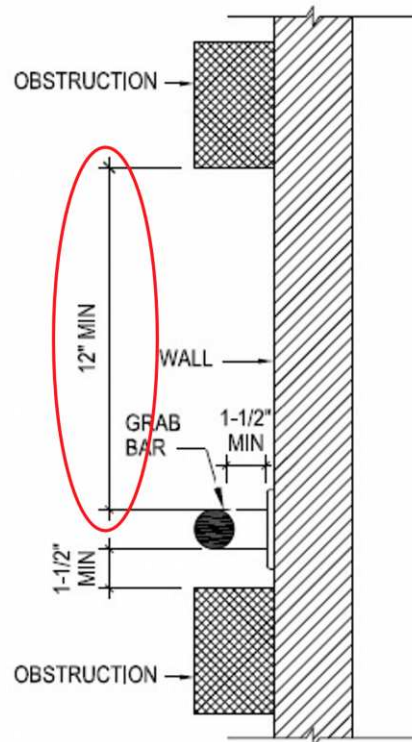
Barrier: 17

Restrooms: Men's

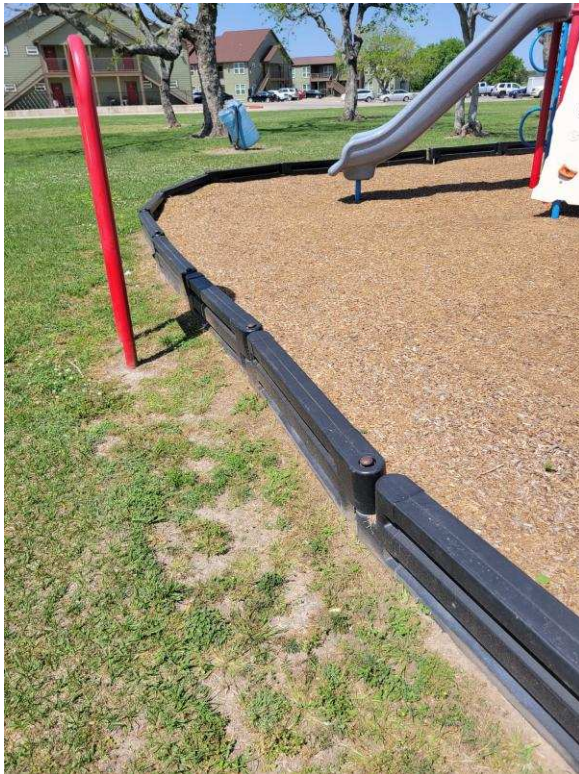
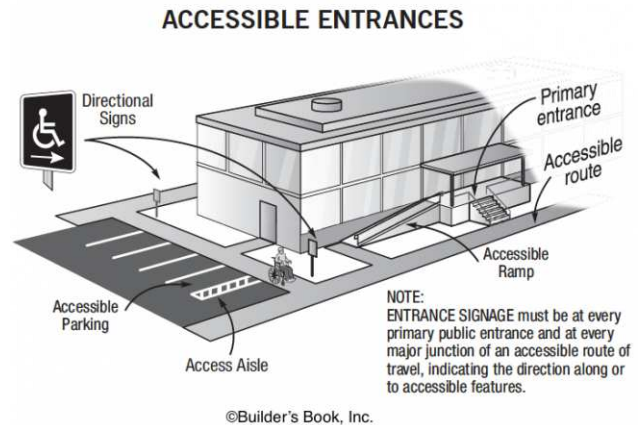
Barrier: 3

Level 5 (Medium): Access to goods and services issues (DOJ Level 2) – severely out of compliance

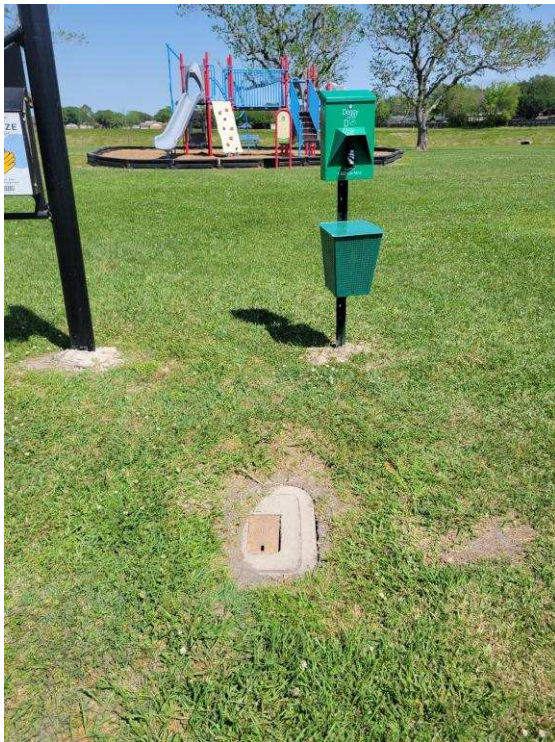
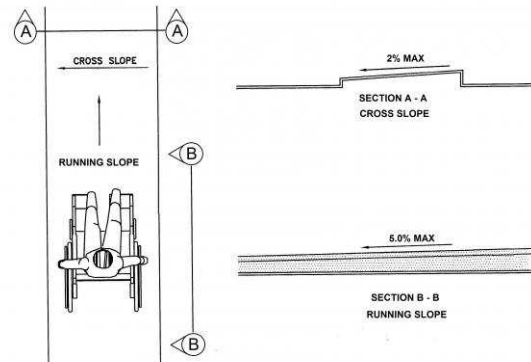
Barrier: 4

Level 5 (Medium): Access to goods and services issues (DOJ Level 2) – severely out of compliance

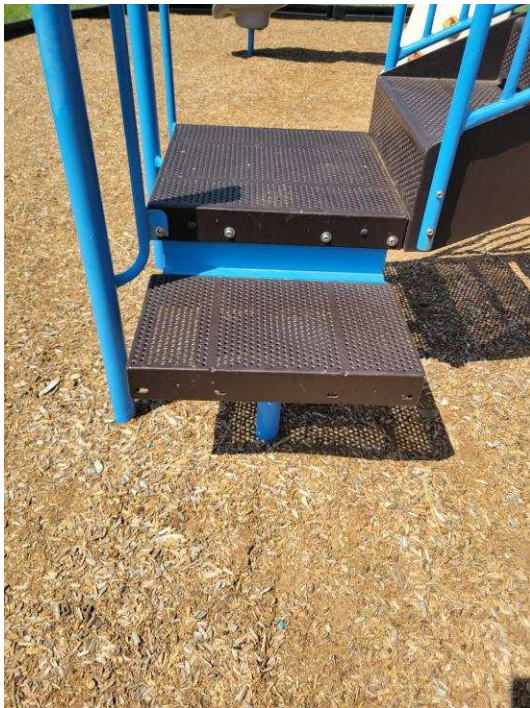
Barrier: 5

Level 8 (Medium): Drinking fountains and public phones (DOJ Level 4 & 5) – moderately out of compliance

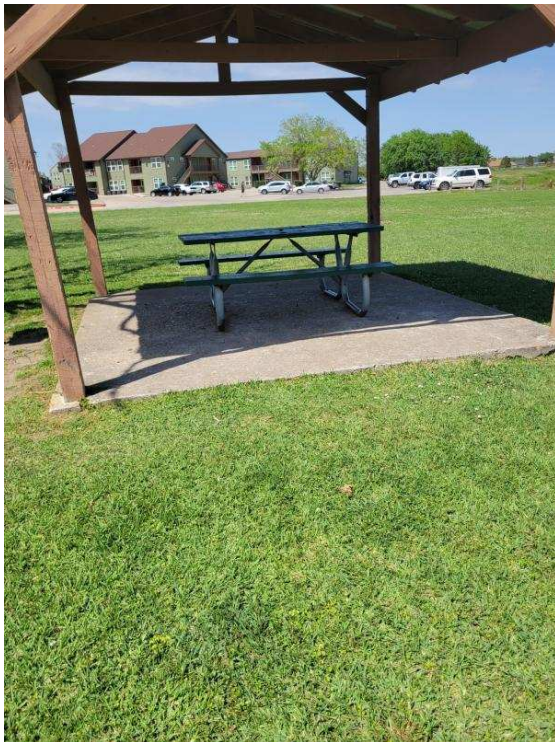
Barrier: 6

Level 5 (Medium): Access to goods and services issues (DOJ Level 2) – severely out of compliance

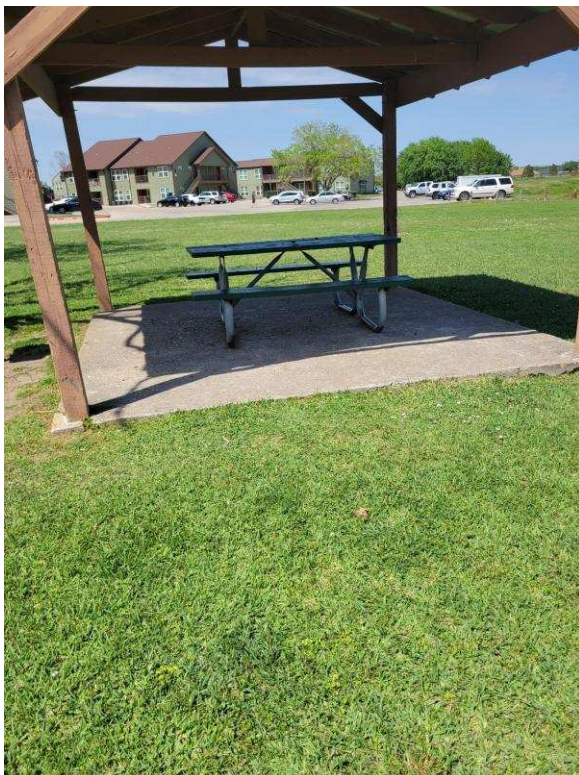
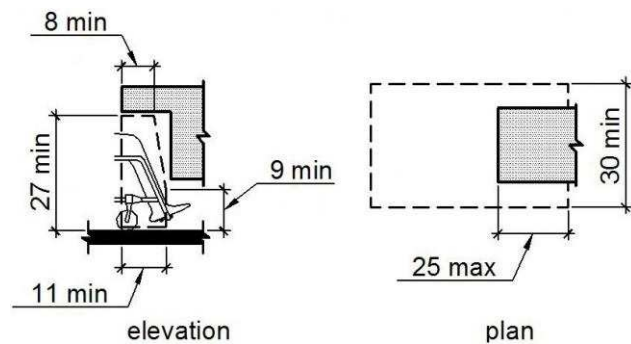
Barrier: 7

Level 5 (Medium): Access to goods and services issues (DOJ Level 2) – severely out of compliance

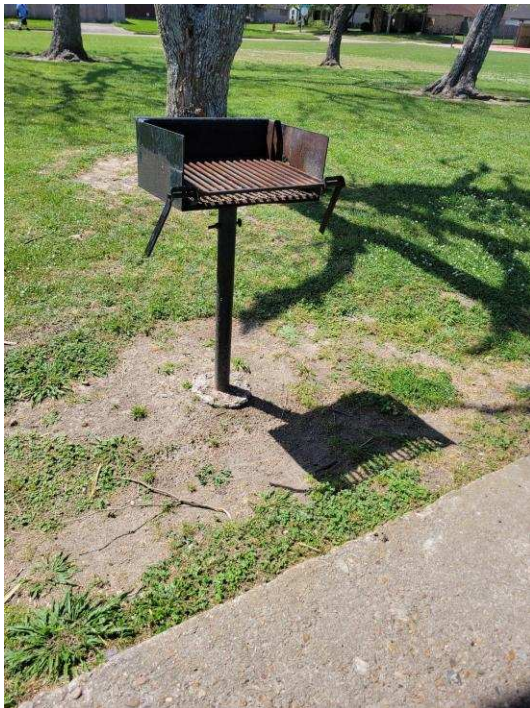
Barrier: 8

Level 5 (Medium): Access to goods and services issues (DOJ Level 2) – severely out of compliance

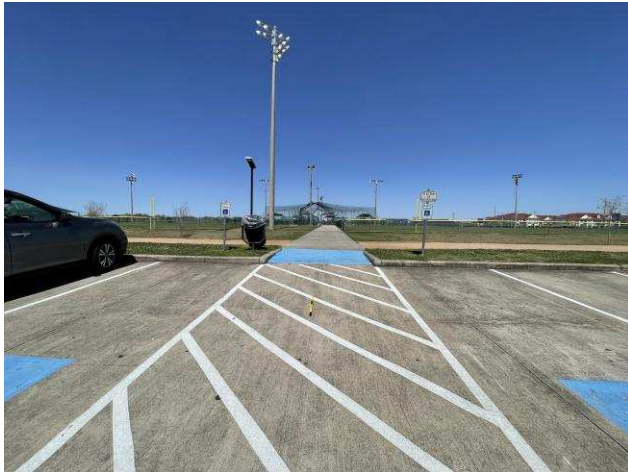
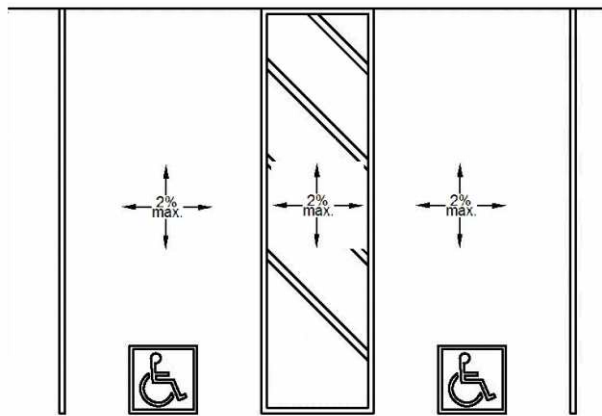
Level 4 (High): Parking and exterior accessible routes (DOJ Level 1) – moderately out of compliance

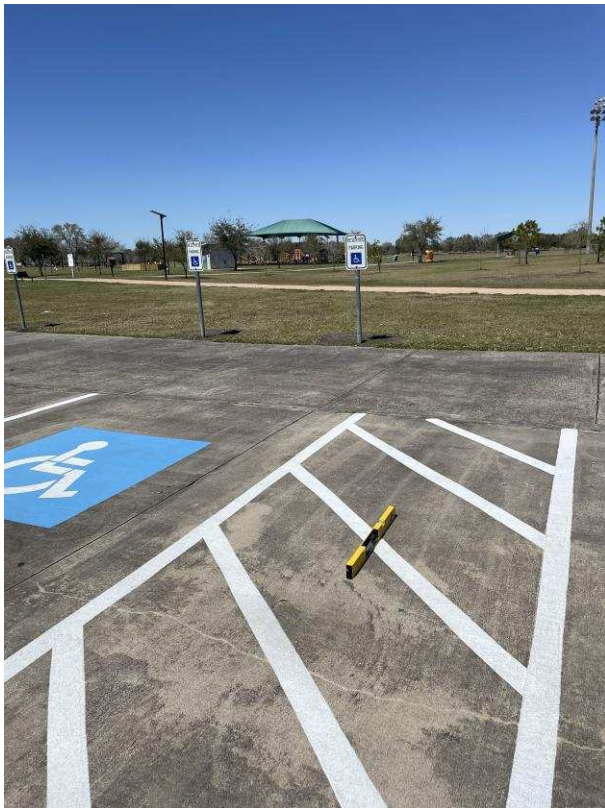
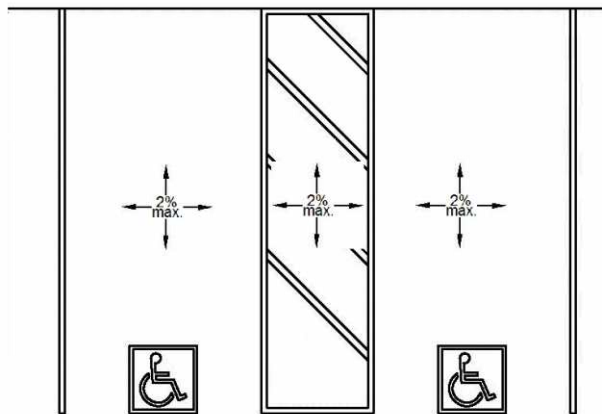
Barrier: 2

Level 4 (High): Parking and exterior accessible routes (DOJ Level 1) – moderately out of compliance

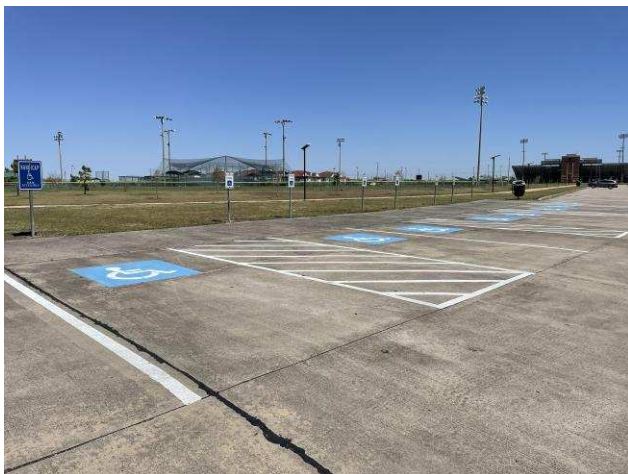
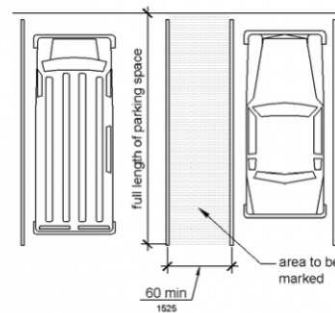
Barrier: 3

Level 6 (Medium): Parking or exterior accessible routes (DOJ Level 1) – minimally out of compliance
Access to goods and services (DOJ Level 2) – moderately out of compliance
Restrooms (DOJ Level 3) – severely out of compliance

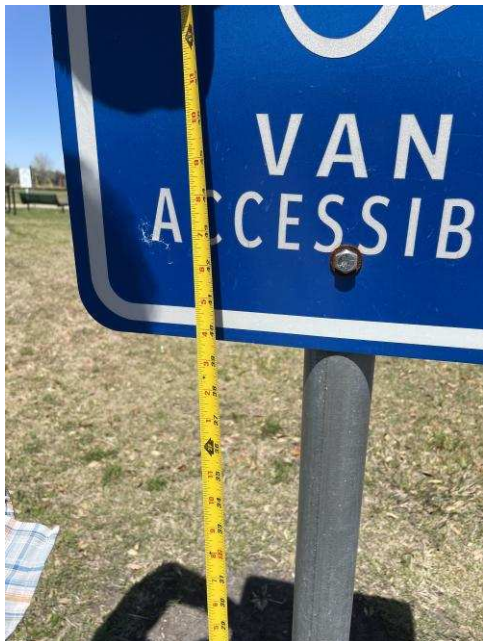
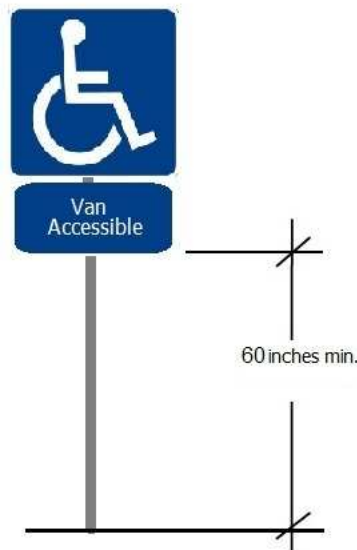
Level 6 (Medium): Parking or exterior accessible routes (DOJ Level 1) – minimally out of compliance
Access to goods and services (DOJ Level 2) – moderately out of compliance
Restrooms (DOJ Level 3) – severely out of compliance

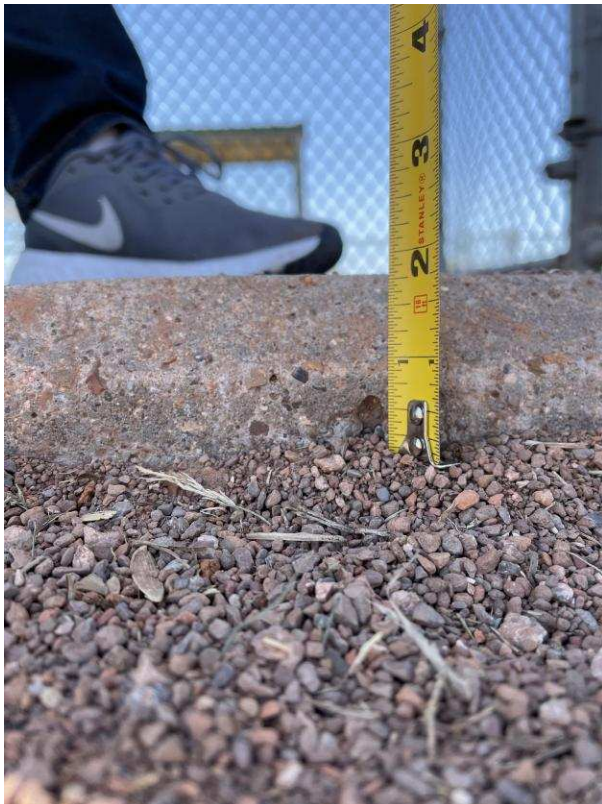
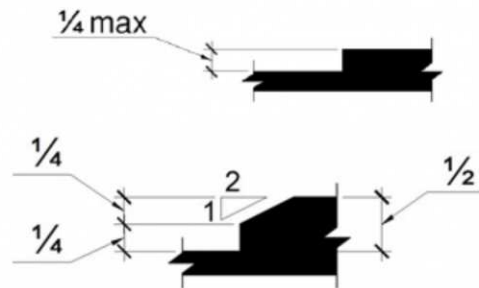
Barrier: 5

Level 2 (High): Parking and exterior accessible routes (DOJ Level 1) – severely out of compliance; near a hospital, school, transit stop, govt. bldg., or other pedestrian attractor

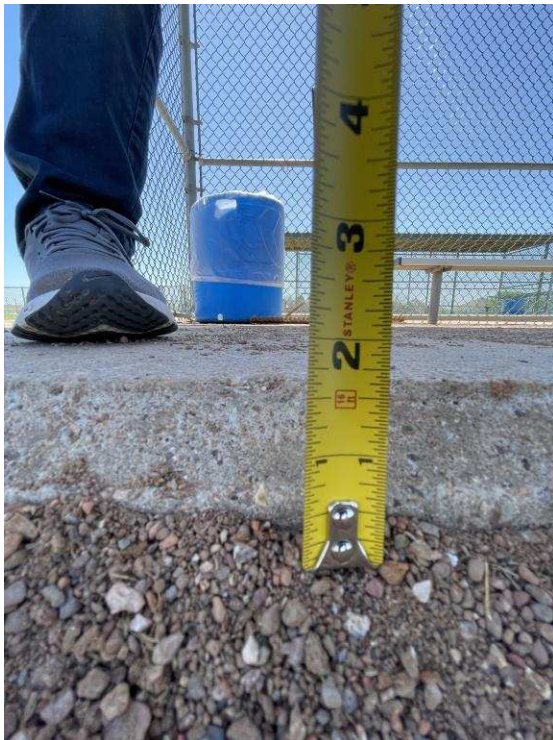
Barrier: 6

Level 5 (Medium): Access to goods and services issues (DOJ Level 2) – severely out of compliance

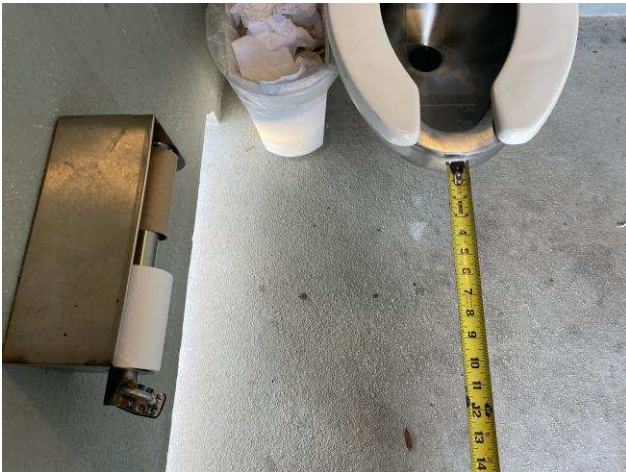
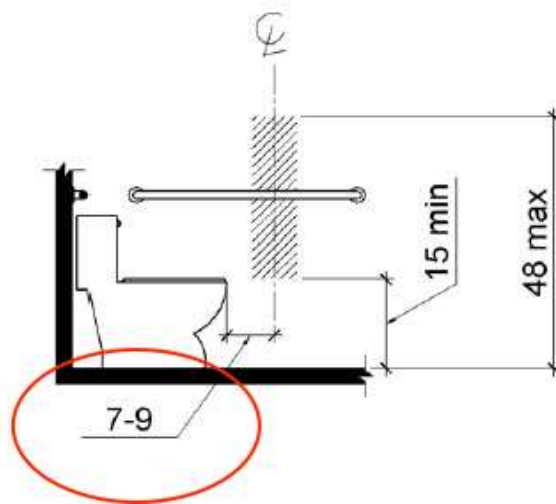
Barrier: 7

Level 9 (Low): Restrooms (DOJ Level 3) – minimally out of compliance

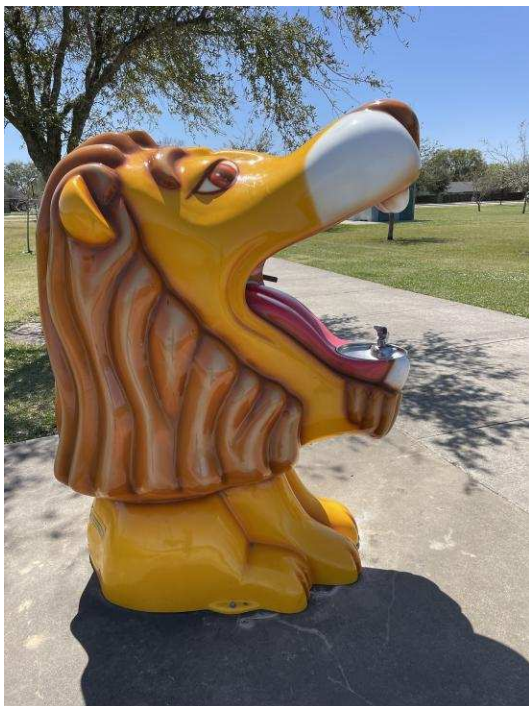
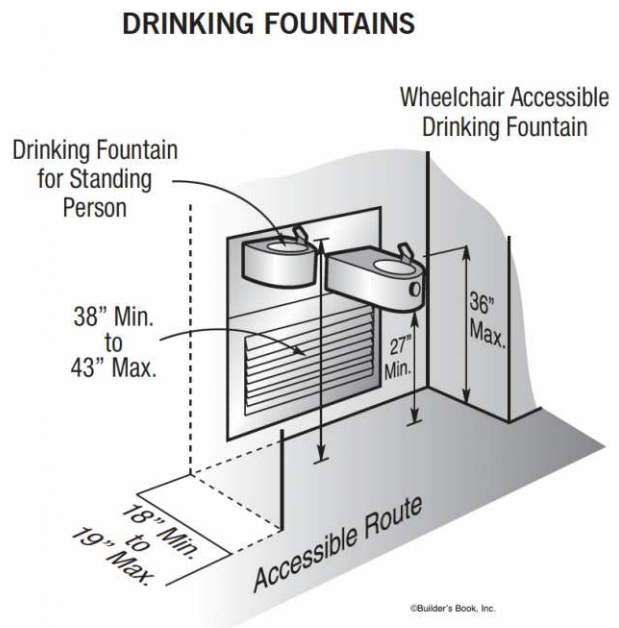
Barrier: 13

The drinking fountain has multiple violations.

Level 5 (Medium): Access to goods and services issues (DOJ Level 2) – severely out of compliance

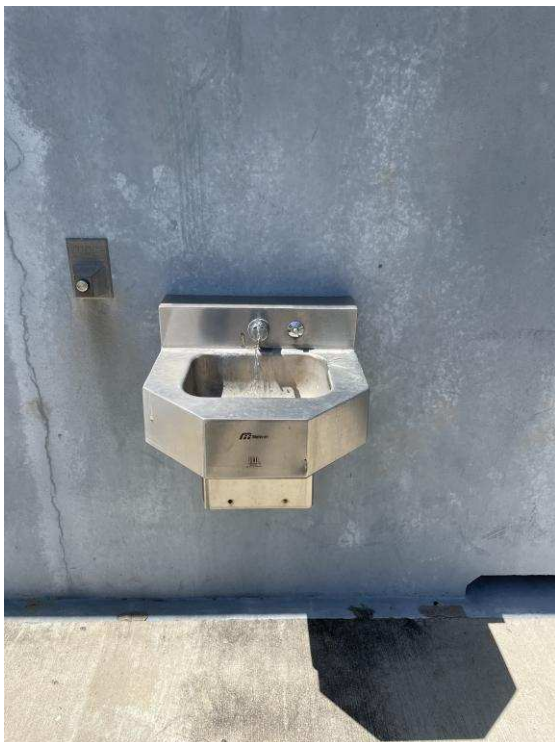
Barrier: 14

Level 8 (Medium): Drinking fountains and public phones (DOJ Level 4 & 5) – moderately out of compliance

Replace the drinking fountain with a compliant fountain.

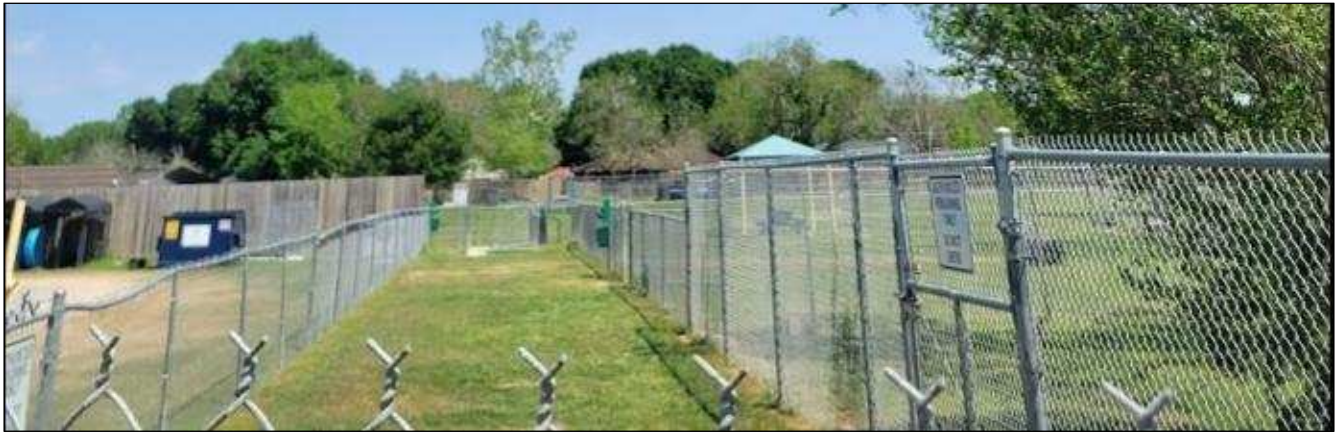
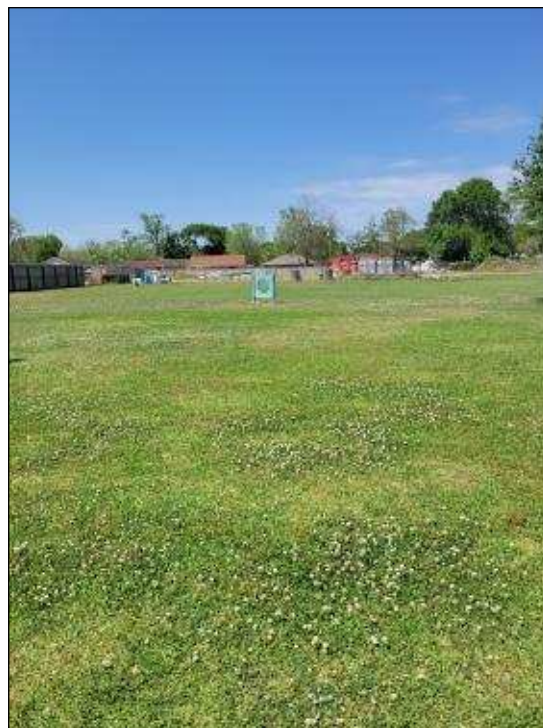
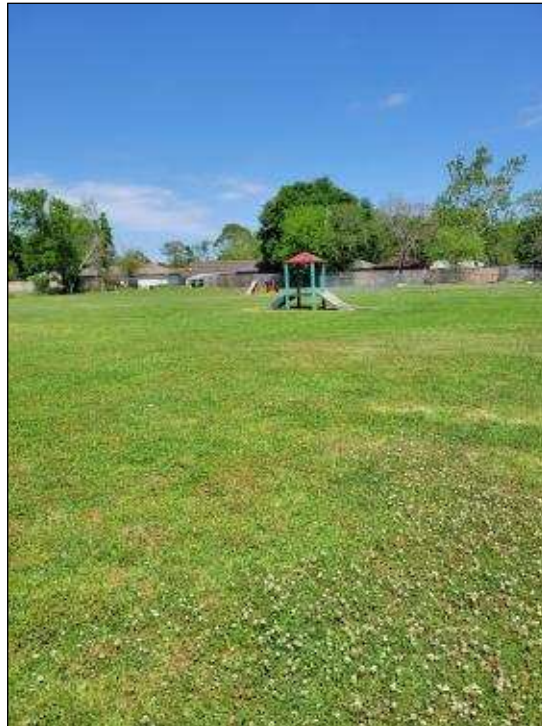
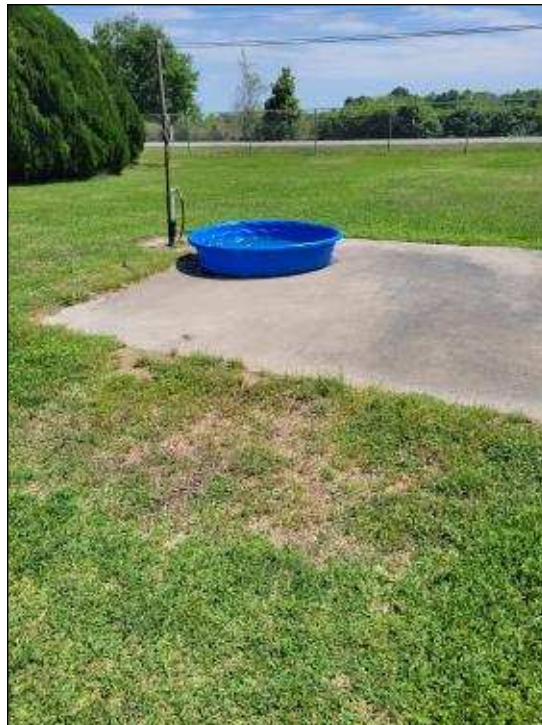
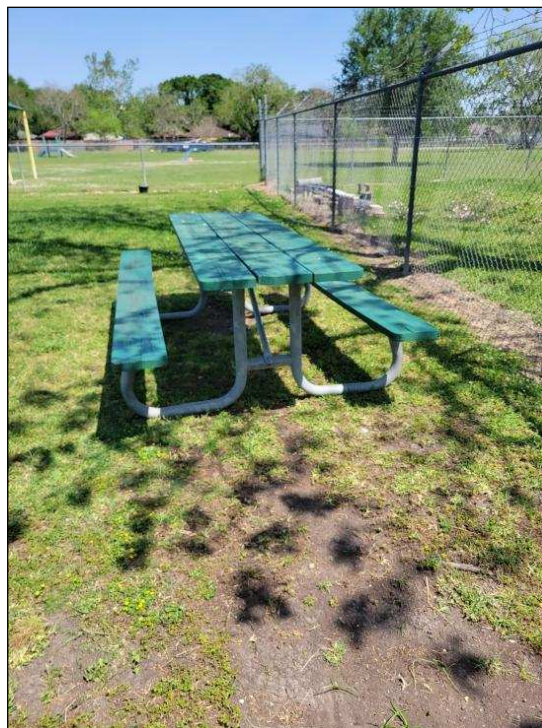
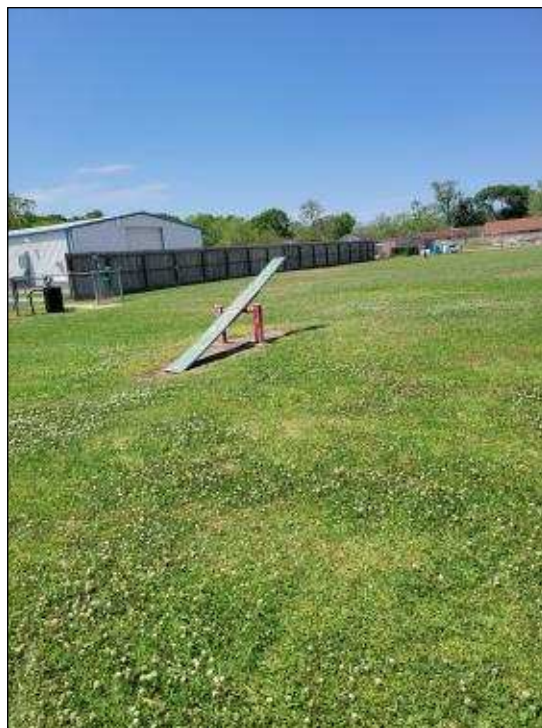
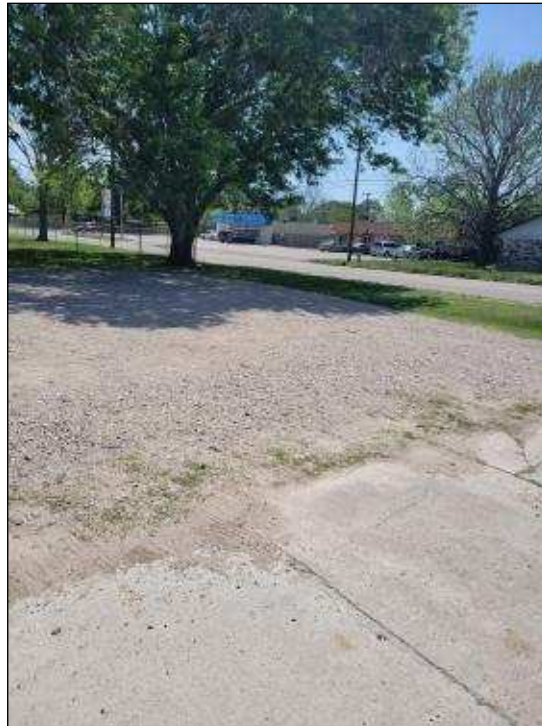
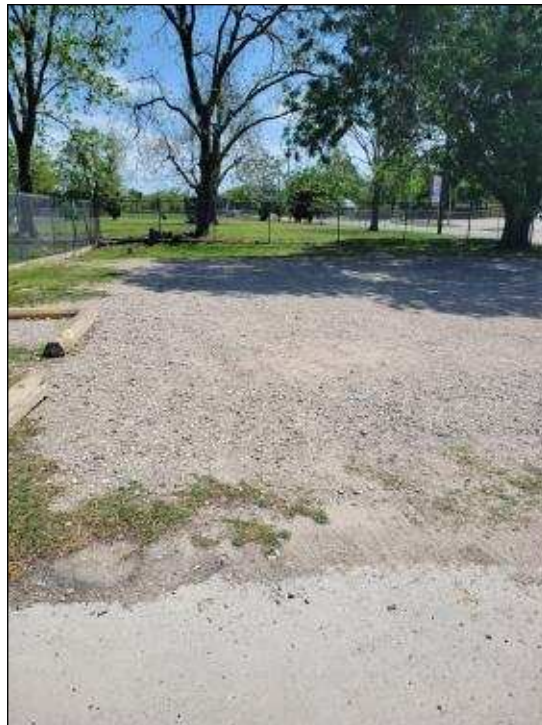
Barrier #1 Additional Barrier Photos

Level 5 (Medium): Access to goods and services issues (DOJ Level 2) – severely out of compliance

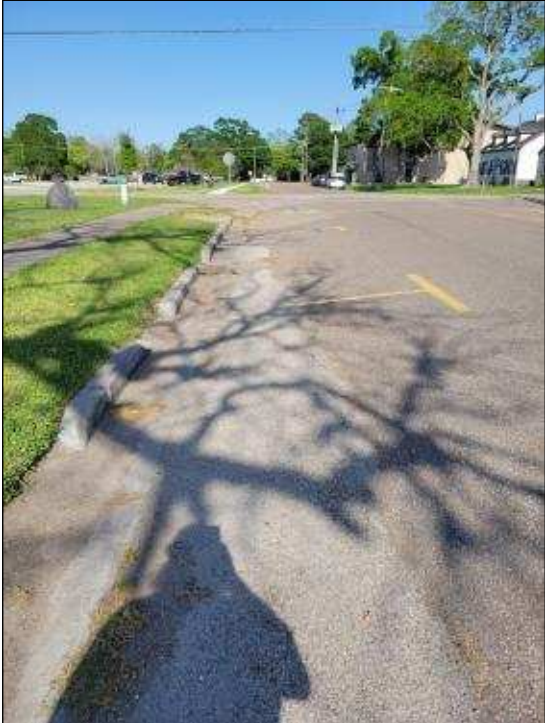
Barrier #1 Additional Barrier Photos

Level 2 (High): Parking and exterior accessible routes (DOJ Level 1) – severely out of compliance; near a hospital, school, transit stop, govt. bldg., or other pedestrian attractor

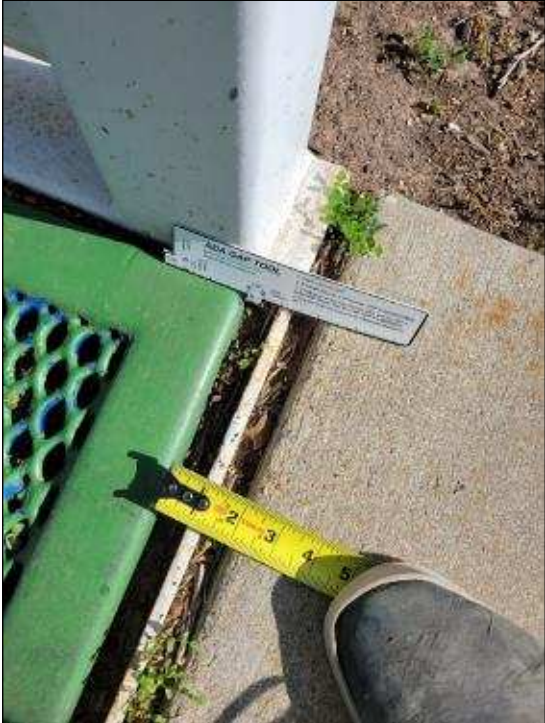
Barrier #4 Additional Barrier Photos

Level 4 (High): Parking and exterior accessible routes (DOJ Level 1) – moderately out of compliance

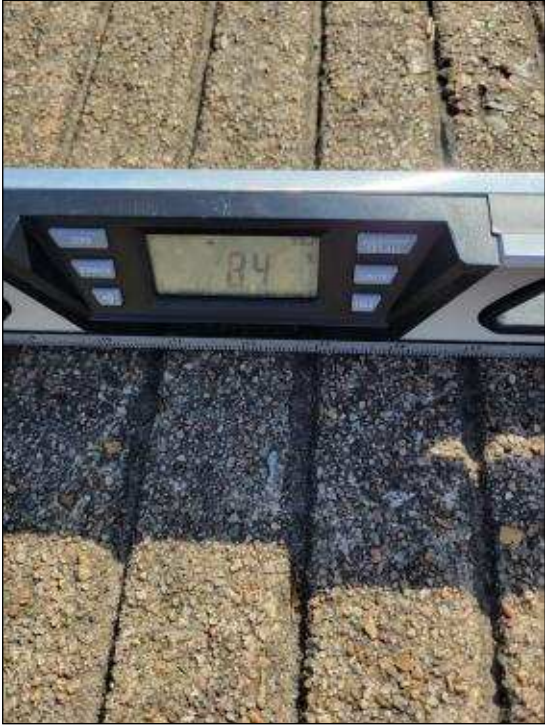
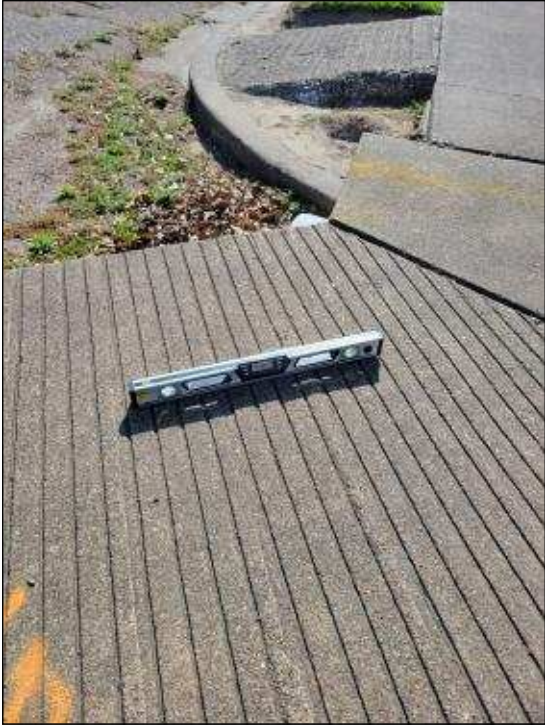
Barrier #5 Additional Barrier Photos

Level 4 (High): Parking and exterior accessible routes (DOJ Level 1) – moderately out of compliance

Replace the curb ramp with a fully compliant curb ramp that includes a level landing area at the top.

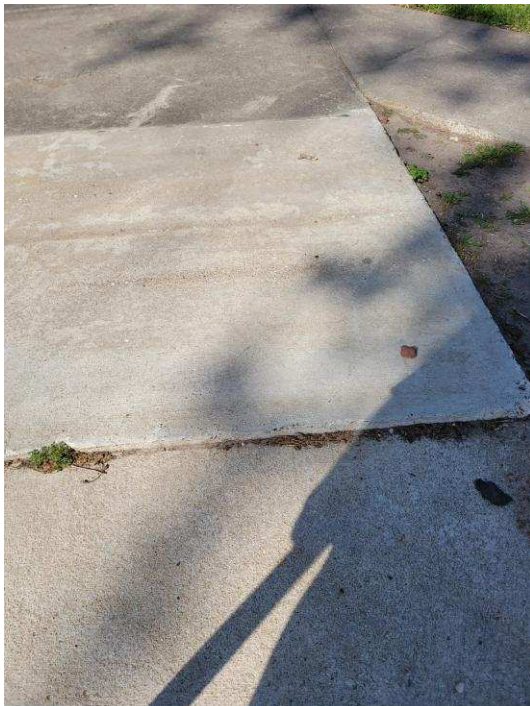
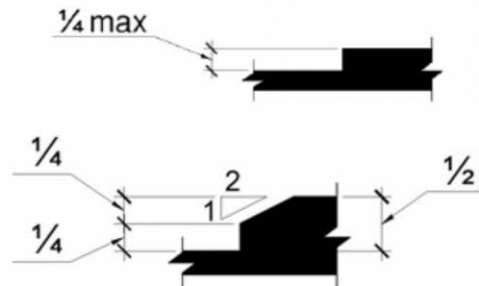
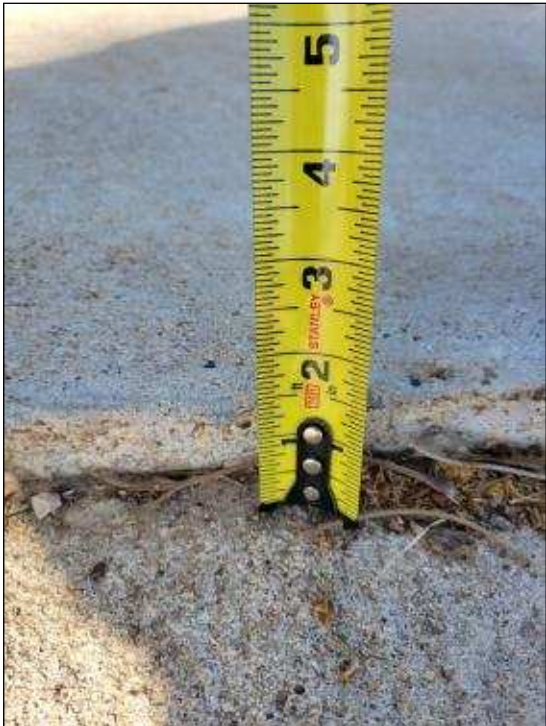
Barrier #6 Additional Barrier Photos

Level 4 (High): Parking and exterior accessible routes (DOJ Level 1) – moderately out of compliance

Remove and replace the section of concrete that has the level change.

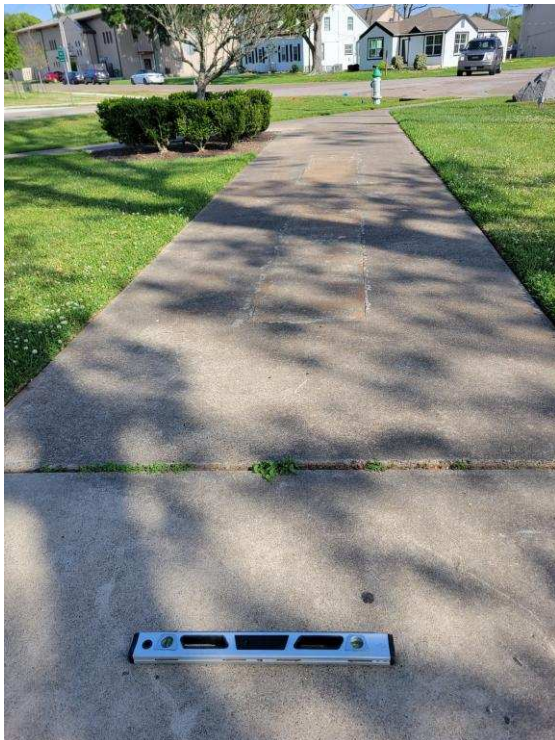
Barrier #7 Additional Barrier Photos

Level 4 (High): Parking and exterior accessible routes (DOJ Level 1) – moderately out of compliance

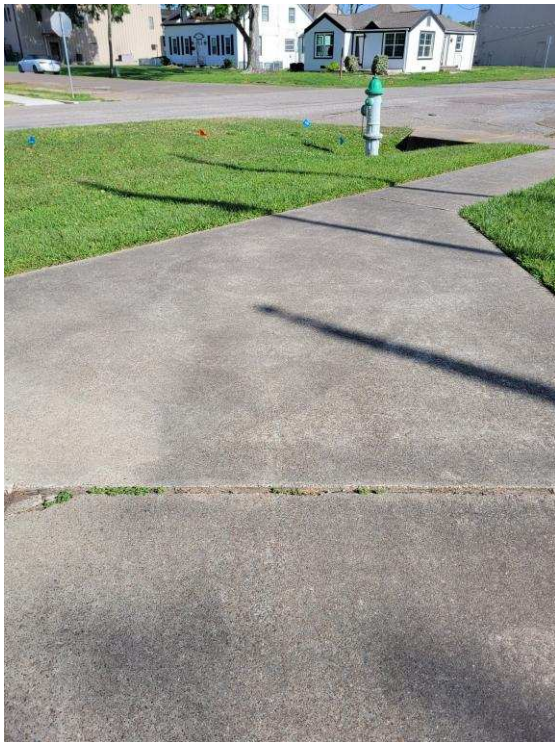
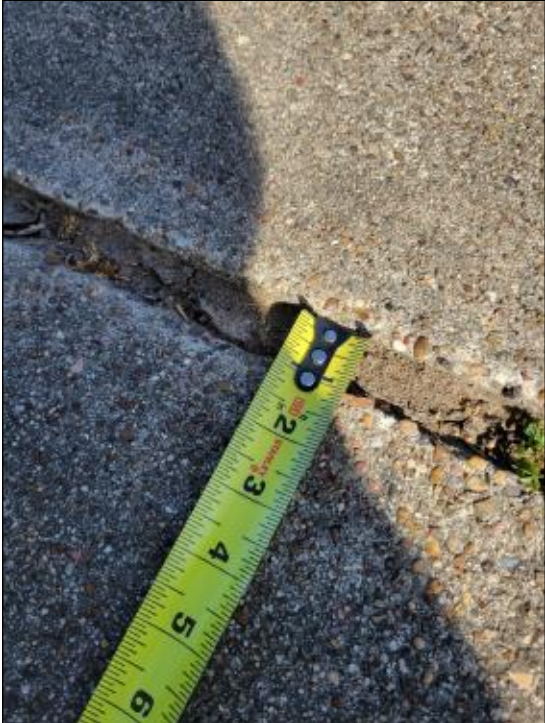
Barrier #8 Additional Barrier Photos

Level 4 (High): Parking and exterior accessible routes (DOJ Level 1) – moderately out of compliance

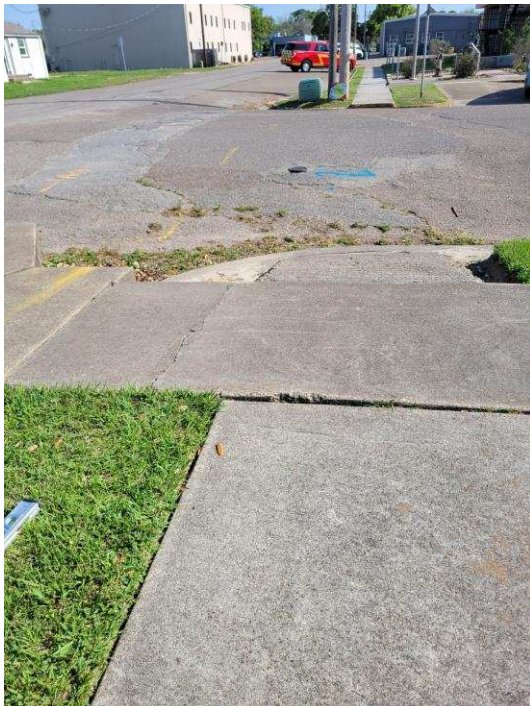
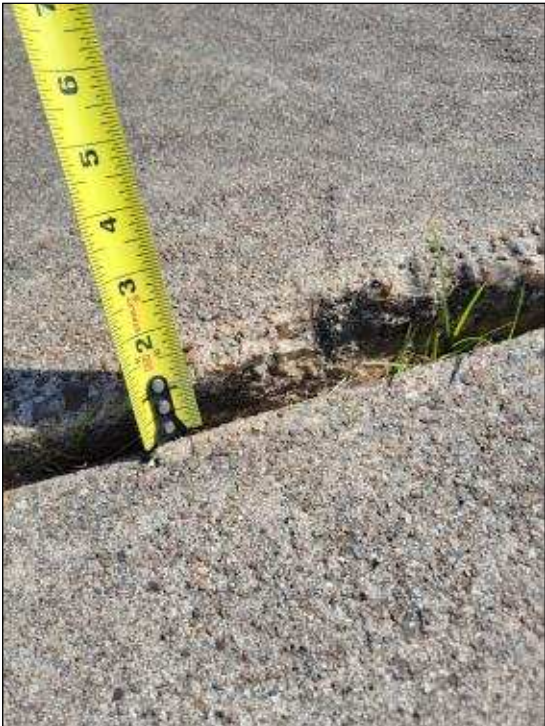
Barrier #9 Additional Barrier Photos

Level 4 (High): Parking and exterior accessible routes (DOJ Level 1) – moderately out of compliance

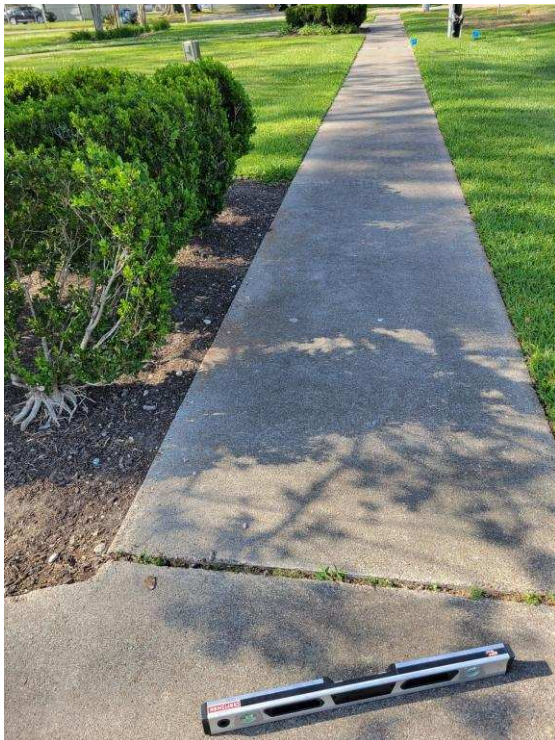
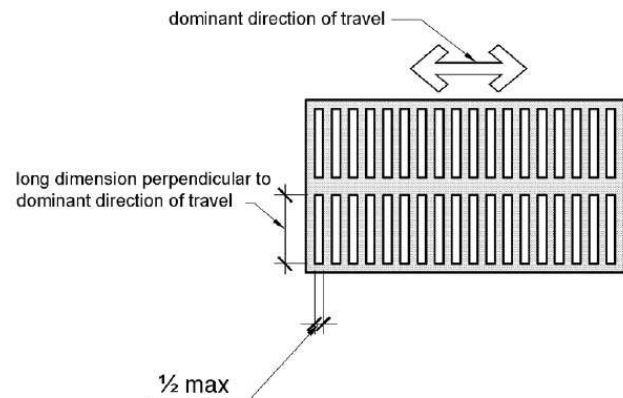
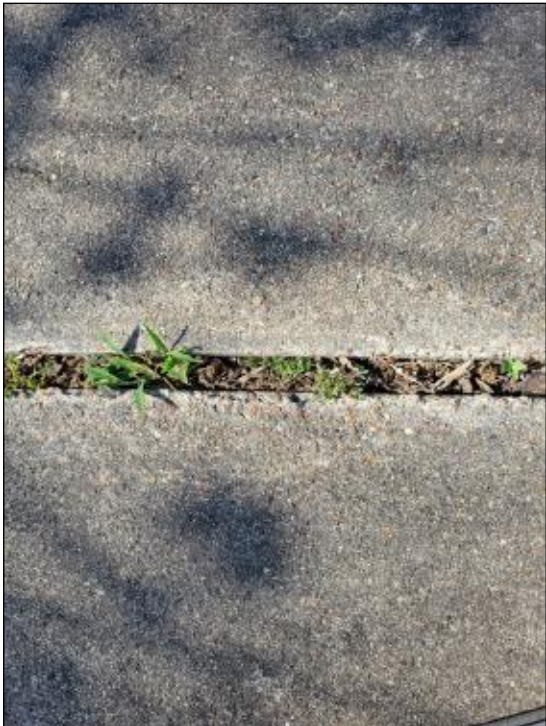
Barrier #10 Additional Barrier Photos

Level 4 (High): Parking and exterior accessible routes (DOJ Level 1) – moderately out of compliance

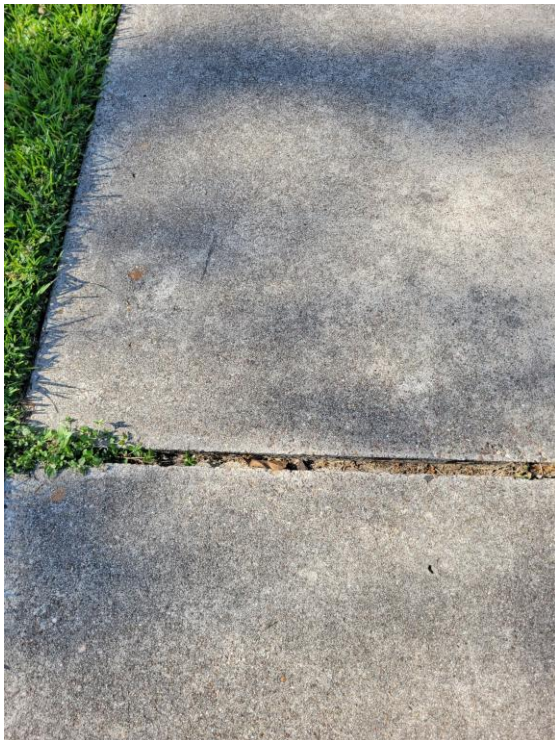
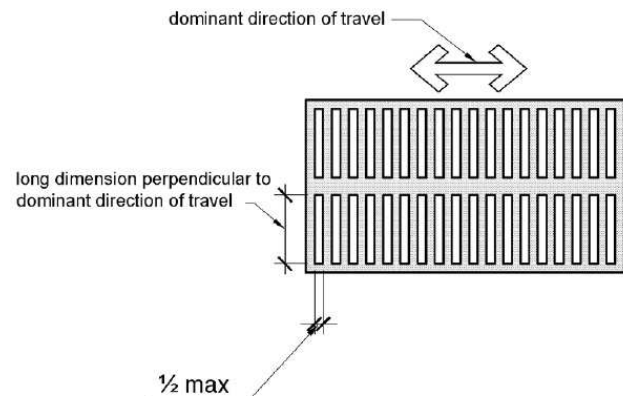
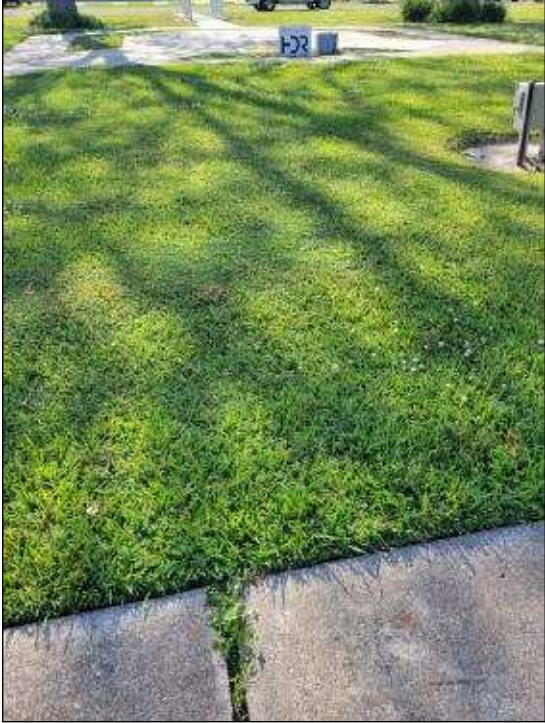
Barrier #11 Additional Barrier Photos

Level 4 (High): Parking and exterior accessible routes (DOJ Level 1) – moderately out of compliance

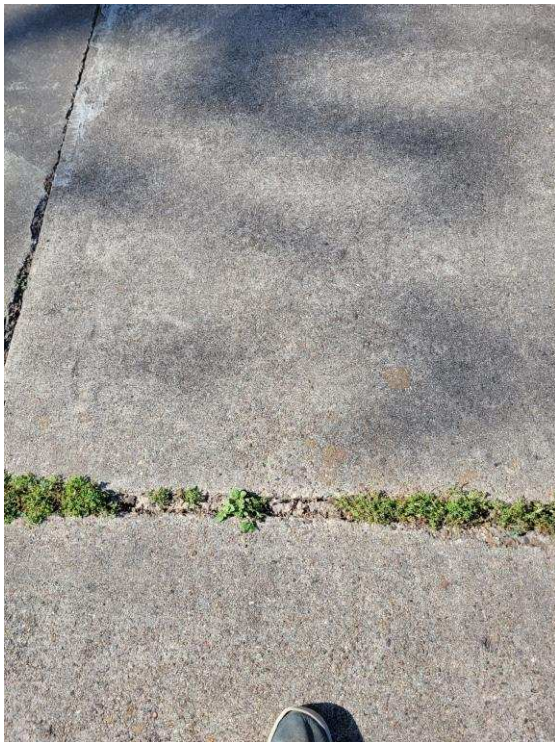
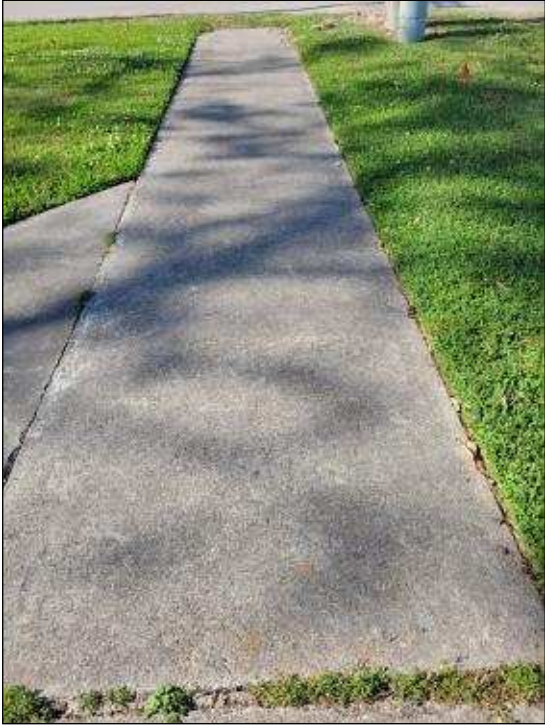
Barrier #12 Additional Barrier Photos

Level 4 (High): Parking and exterior accessible routes (DOJ Level 1) – moderately out of compliance
