City of Angleton, Texas

Americans with Disabilities Act (ADA) Self-Evaluation & Transition Plan

September 2022

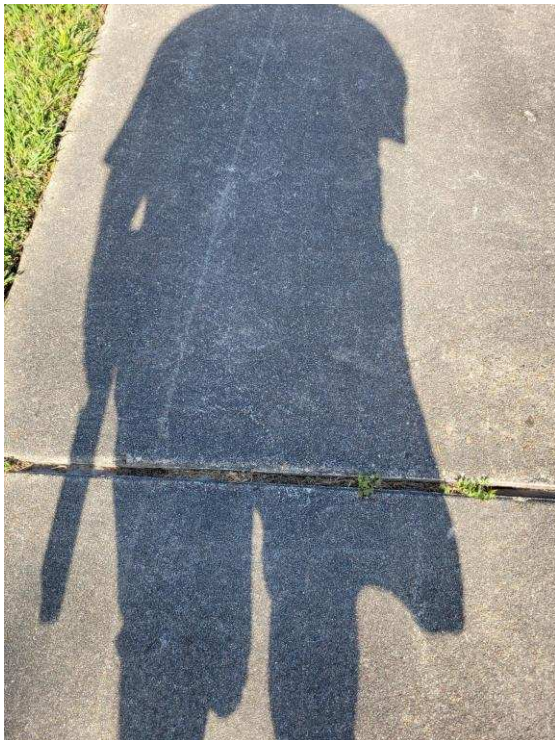
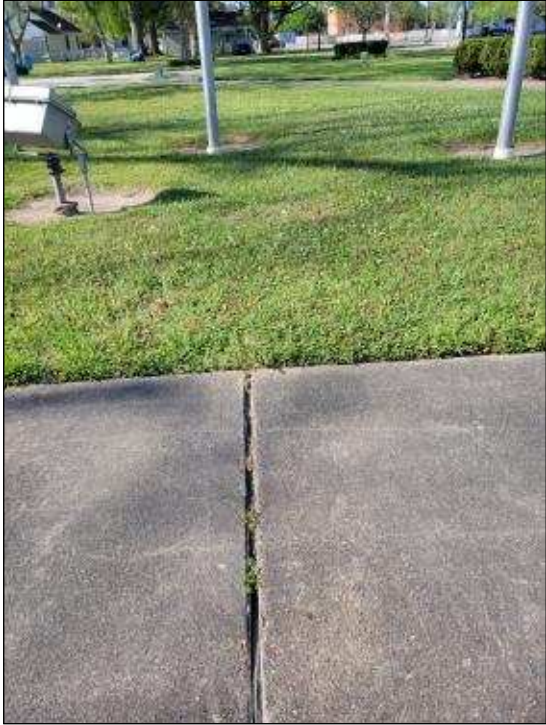
Barrier #13 Additional Barrier Photos

Level 4 (High): Parking and exterior accessible routes (DOJ Level 1) – moderately out of compliance

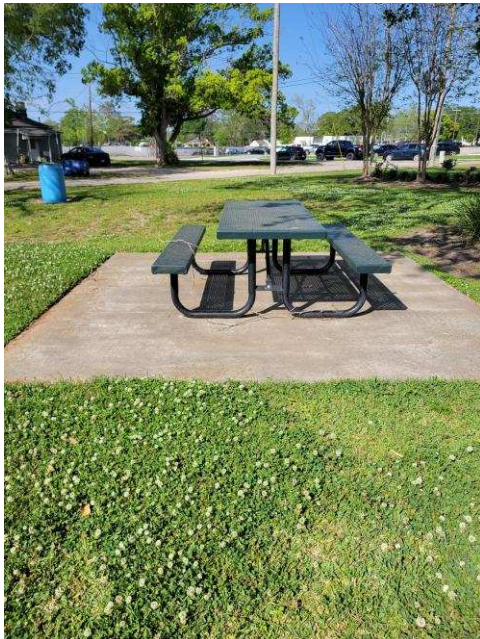
Level 6 (Medium): Parking or exterior accessible routes (DOJ Level 1) – minimally out of compliance
Access to goods and services (DOJ Level 2) – moderately out of compliance
Restrooms (DOJ Level 3) – severely out of compliance

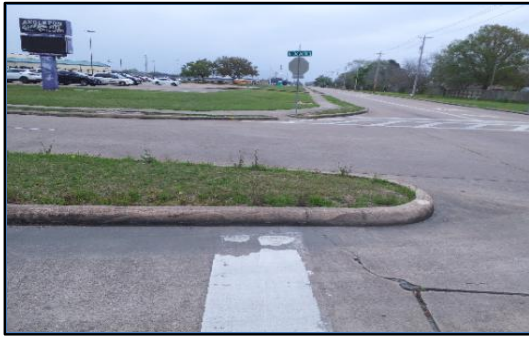
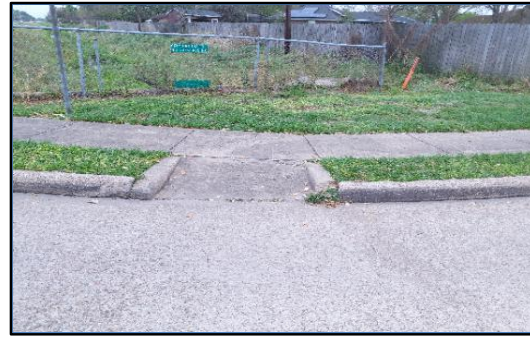
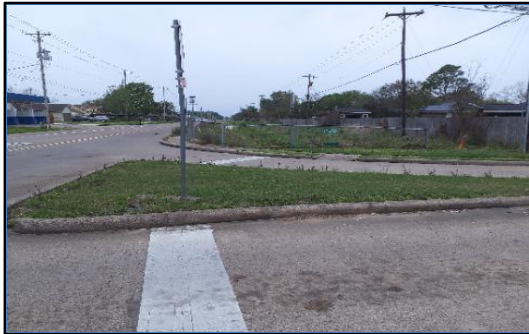
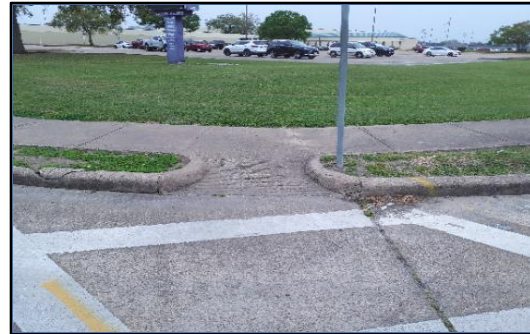
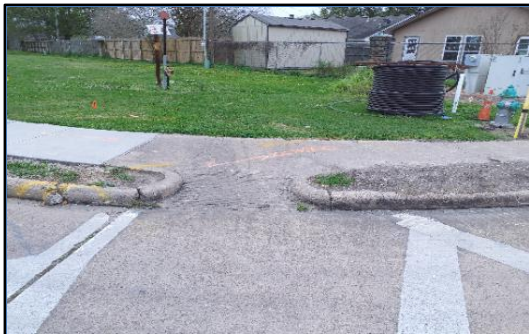
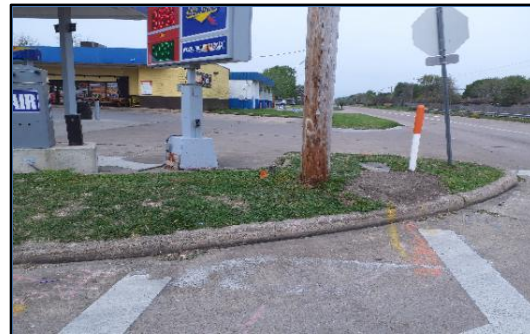
Turning space length is less than 4' (or 5' when constrained)							
Turning space width is less than 4' (or 5' when constrained)							
Turning space running slope is greater than 2%		X					
Turning space cross slope greater than 2%		X					
Temporary obstruction (>0.25') in curb ramp/landings/flares							
Non-compliant detectable warning surface (DWS)							
No detectable warning surface (DWS)							
Curb ramp transition onto roadway is greater than 0.25"							
Counter slope of the gutter or street at the foot of the curb ramp is greater than 5%							
Ponding occurs at base of curb ramp				X	X

Comment: Existing sidewalk, curb ramp, and/or striping configurations permit pedestrians to cross the major street. An Engineering study is needed to confirm crossing should be accommodated at this location and the current crossing treatment is appropriate.

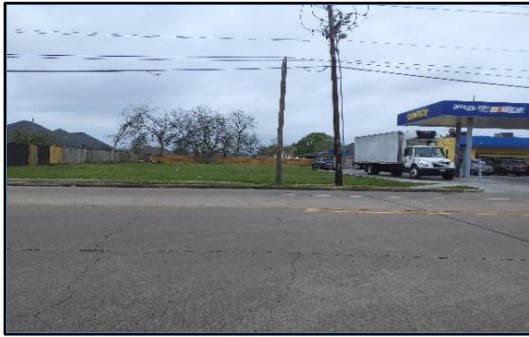
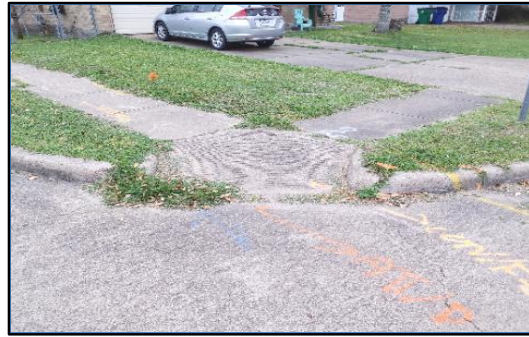
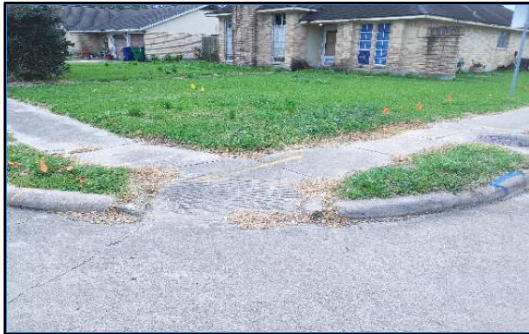
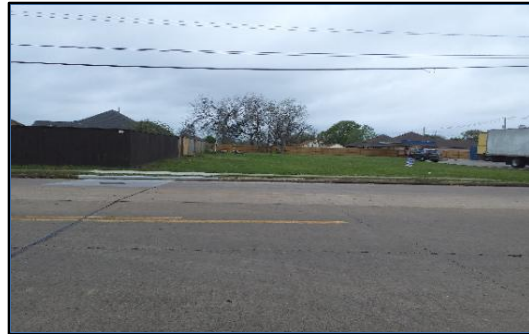
Turning space width is less than 4' (or 5' when constrained)					
Turning space running slope is greater than 2%					
Turning space cross slope greater than 2%					
Temporary obstruction (>0.25') in curb ramp/landing/flares			X		
Non-compliant detectable warning surface (DWS)					
No detectable warning surface (DWS)					Remove temporary obstruction
Curb ramp transition onto roadway is greater than 0.25"					
Counter slope of the gutter or street at the foot of the curb ramp is greater than 5%		X			
Ponding occurs at base of curb ramp		X	X		Fix curb ramp counter slope
					Fix ponding

Comment: Existing sidewalk, curb ramp, and/or striping configurations permit pedestrians to cross the major street. An Engineering study is needed to confirm crossing should be accommodated at this location and the current crossing treatment is appropriate.

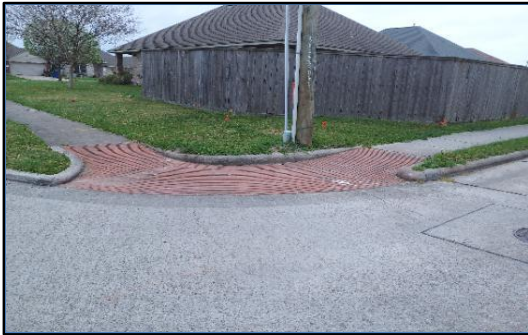
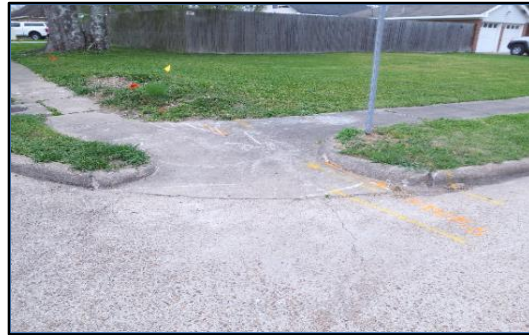
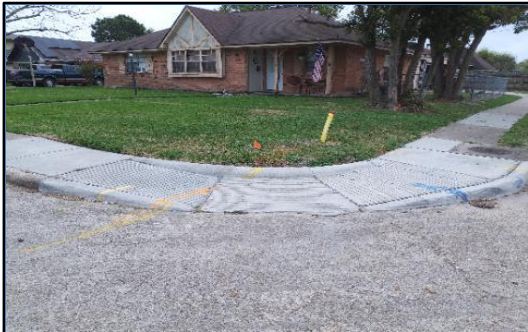
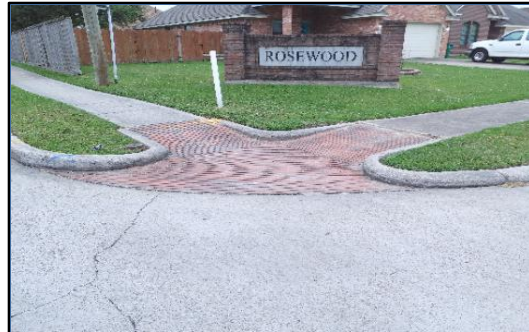
Turning space width is less than 4' (or 5' when constrained)			X		
Turning space running slope is greater than 2%			X		
Turning space cross slope greater than 2%			X		
Temporary obstruction (>0.25') in curb ramp/landing/flares					
Non-compliant detectable warning surface (DWS)					
No detectable warning surface (DWS)					
Curb ramp transition onto roadway is greater than 0.25"		X			Fix curb ramp transition
Counter slope of the gutter or street at the foot of the curb ramp is greater than 5%					
Ponding occurs at base of curb ramp

Comment: Existing sidewalk, curb ramp, and/or striping configurations permit pedestrians to cross the major street. An Engineering study is needed to confirm crossing should be accommodated at this location and the current crossing treatment is appropriate.

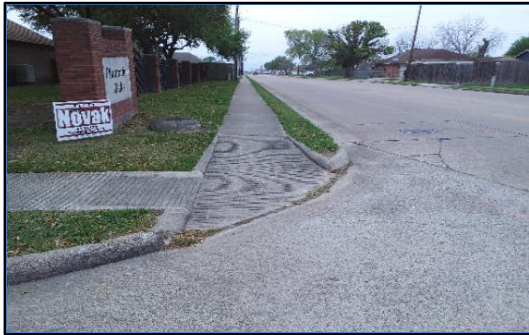
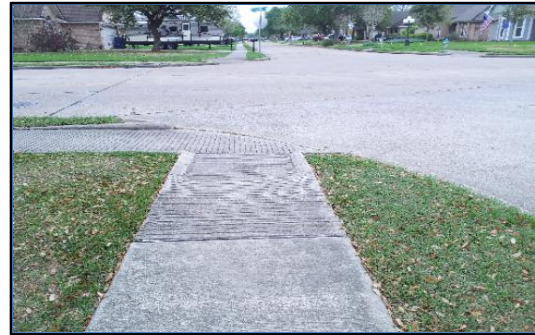
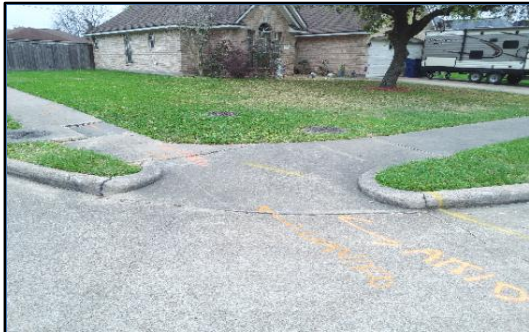
Curb Ramp Issues	Curb Ramp ID ('z', 'l', or 'CN' in ramp label indicates no existing ramp)						Possible Solutions
	1A	1B	2A	3A	4A	4B	
Curb ramp does not exist and is needed							Remove and replace curb ramp
Curb ramp does not land in crosswalk							
No 4' x 4' clear space at base of curb ramp							
Curbed side is not 90° or has traversable adjacent surface							
Flare cross slope is greater than 10%							
Curb ramp running slope is greater than 8.3%							
Blended transition running slope is greater than 5%							
Cut-thru ramp running slope is greater than 5%							
Curb ramp cross slope is greater than 2%	X	X		X	X	X	
Cut-thru ramp cross slope is greater than 2%							
Curb ramp width is less than 48"	X	X			X	X	
Cut-thru ramp width is less than 60"							
Permanent obstruction (>0.25') in curb ramp/landing/flares				X	X		
Turning space does not exist and is needed				X	X		
Turning space length is less than 4' (or 5' when constrained)				X	X

Turning space width is less than 4' (or 5' when constrained)				X	X		
Turning space running slope is greater than 2%							
Turning space cross slope greater than 2%		X			X	X	
Temporary obstruction (>0.25') in curb ramp/landing/flares							
Non-compliant detectable warning surface (DWS)							
No detectable warning surface (DWS)							
Curb ramp transition onto roadway is greater than 0.25"				X			
Counter slope of the gutter or street at the foot of the curb ramp is greater than 5%							
Ponding occurs at base of curb ramp	X				X	X

Comment: Existing sidewalk, curb ramp, and/or striping configurations permit pedestrians to cross the major street. An Engineering study is needed to confirm crossing should be accommodated at this location and the current crossing treatment is appropriate.

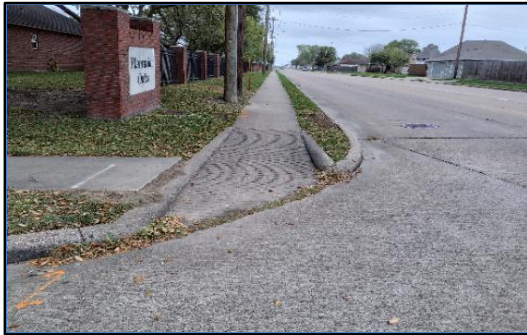
Ramp 1A

Curb Ramp Issues	Curb Ramp ID ('z', 'l', or 'CN' in ramp label indicates no existing ramp)					Possible Solutions
	1A	2A	3A	4A	4B	
Curb ramp does not exist and is needed						Remove and replace curb ramp
Curb ramp does not land in crosswalk						
No 4' x 4' clear space at base of curb ramp						
Curbed side is not 90° or has traversable adjacent surface	X					
Flare cross slope is greater than 10%						
Curb ramp running slope is greater than 8.3%			X			
Blended transition running slope is greater than 5%						
Cut-thru ramp running slope is greater than 5%						
Curb ramp cross slope is greater than 2%	X	X		X	X	
Cut-thru ramp cross slope is greater than 2%						
Curb ramp width is less than 48"	X			X	X	
Cut-thru ramp width is less than 60"						
Permanent obstruction (>0.25') in curb ramp/landings/flares	X					
Turning space does not exist and is needed		X	X			
Turning space length is less than 4' (or 5' when constrained)

Turning space width is less than 4' (or 5' when constrained)						
Turning space running slope is greater than 2%						
Turning space cross slope greater than 2%	X			X		
Temporary obstruction (>0.25') in curb ramp/landings/flares						
Non-compliant detectable warning surface (DWS)						
No detectable warning surface (DWS)						
Curb ramp transition onto roadway is greater than 0.25"			X			
Counter slope of the gutter or street at the foot of the curb ramp is greater than 5%						
Ponding occurs at base of curb ramp	X		X	X	X

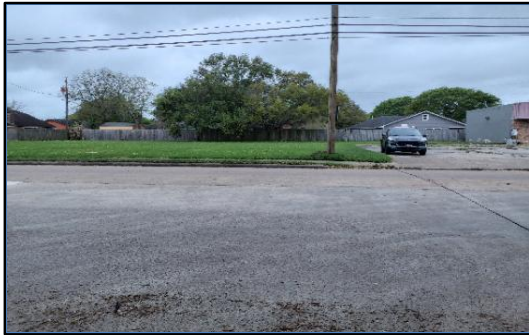
Corner 1 No Ramp (1z)

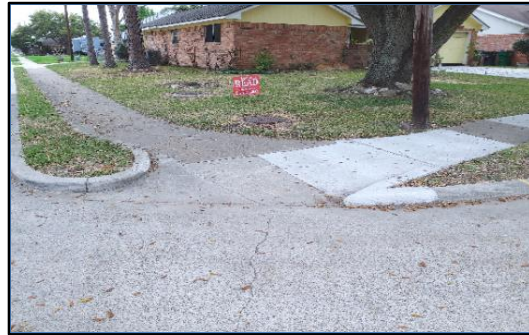
Ramp 2A

Turning space width is less than 4' (or 5' when constrained)					
Turning space running slope is greater than 2%					
Turning space cross slope greater than 2%					
Temporary obstruction (>0.25') in curb ramp/landing/flares					
Non-compliant detectable warning surface (DWS)					
No detectable warning surface (DWS)					Fix curb ramp transition
Curb ramp transition onto roadway is greater than 0.25"			X		
Counter slope of the gutter or street at the foot of the curb ramp is greater than 5%					Fix ponding
Ponding occurs at base of curb ramp		X	X

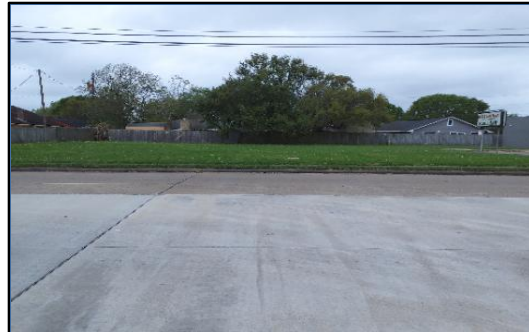
Corner 4 No Ramp (4z)

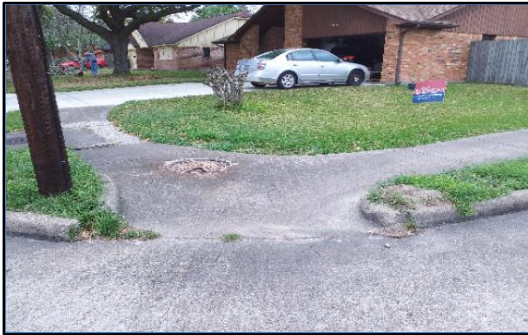
Ramp 1A

Curb Ramp Issues	Curb Ramp ID ('z', 'l', or 'CN' in ramp label indicates no existing ramp)				Possible Solutions
	1A	2A	3A	4A	
Curb ramp does not exist and is needed					Remove and replace curb ramp
Curb ramp does not land in crosswalk					
No 4' x 4' clear space at base of curb ramp					
Curbed side is not 90° or has traversable adjacent surface					
Flare cross slope is greater than 10%					
Curb ramp running slope is greater than 8.3%	X		X		
Blended transition running slope is greater than 5%					
Cut-thru ramp running slope is greater than 5%					
Curb ramp cross slope is greater than 2%				X	
Cut-thru ramp cross slope is greater than 2%					
Curb ramp width is less than 48"					
Cut-thru ramp width is less than 60"					
Permanent obstruction (>0.25') in curb ramp/landings/flares	X		X		
Turning space does not exist and is needed	X	X	X	X	
Turning space length is less than 4' (or 5' when constrained)

Turning space width is less than 4' (or 5' when constrained)					
Turning space running slope is greater than 2%					
Turning space cross slope greater than 2%					
Temporary obstruction (>0.25') in curb ramp/landings/flares					
Non-compliant detectable warning surface (DWS)					
No detectable warning surface (DWS)					
Curb ramp transition onto roadway is greater than 0.25"					
Counter slope of the gutter or street at the foot of the curb ramp is greater than 5%					
Ponding occurs at base of curb ramp	X	X	X		Fix ponding

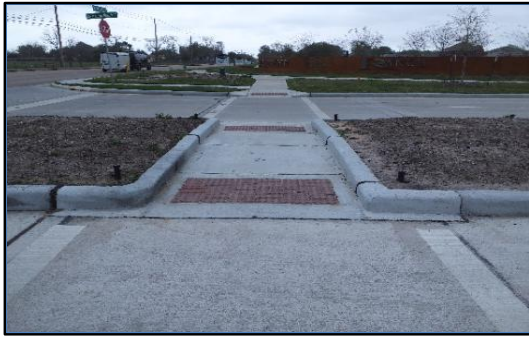
Ramp East F

Turning space running slope is greater than 2%						
Turning space cross slope greater than 2%						
Temporary obstruction (>0.25") in curb ramp/landings/flares						
Non-compliant detectable warning surface (DWS)	X					Curb ramp is compliant - bring DWS into compliance
No detectable warning surface (DWS)						
Curb ramp transition onto roadway is greater than 0.25"						
Counter slope of the gutter or street at the foot of the curb ramp is greater than 5%						
Ponding occurs at base of curb ramp

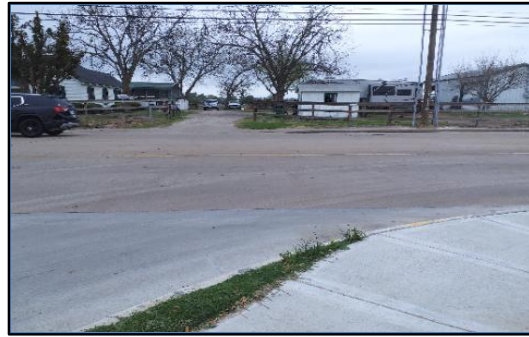
Corner 1 No Ramp (1z)

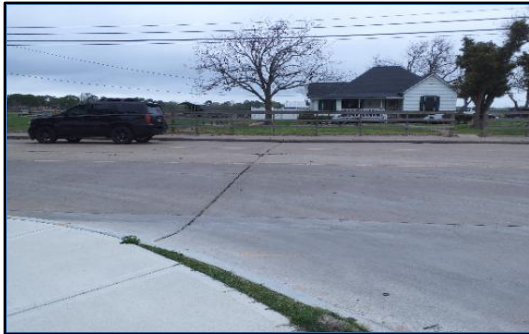
Corner 4 No Ramp (4z)

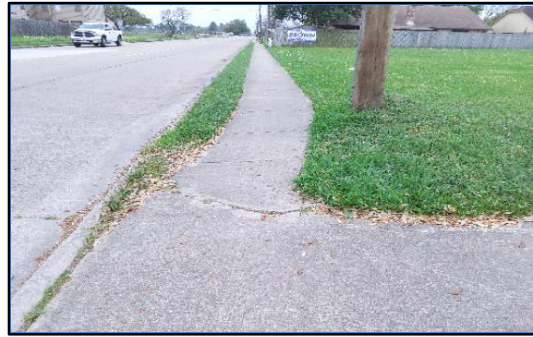
Ramp 4A

Curb Ramp Issues	Curb Ramp ID ('z', 'l', or 'CN' in ramp label indicates no existing ramp)		Possible Solutions
	1A	4A	
Curb ramp does not exist and is needed			Remove and replace curb ramp
Curb ramp does not land in crosswalk			
No 4' x 4' clear space at base of curb ramp			
Curbed side is not 90° or has traversable adjacent surface			
Flare cross slope is greater than 10%			
Curb ramp running slope is greater than 8.3%			
Blended transition running slope is greater than 5%			
Cut-thru ramp running slope is greater than 5%			
Curb ramp cross slope is greater than 2%	X	X	
Cut-thru ramp cross slope is greater than 2%			
Curb ramp width is less than 48"			
Cut-thru ramp width is less than 60"			
Permanent obstruction (>0.25') in curb ramp/landing/flares			
Turning space does not exist and is needed			
Turning space length is less than 4' (or 5' when constrained)			
Turning space width is less than 4' (or 5' when constrained)

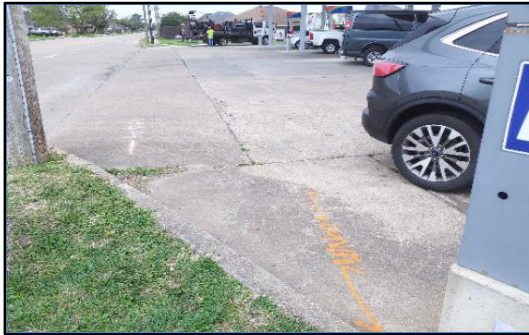
Curb Ramp Issues	Curb Ramp ID ('z', 'i', or 'CN' in ramp label indicates no existing ramp)		Possible Solutions
	1z	4A	
Curb ramp does not exist and is needed	X		Install curb ramp; if median improvement, see shapefile
Curb ramp does not land in crosswalk			
No 4' x 4' clear space at base of curb ramp			
Curbed side is not 90° or has traversable adjacent surface			
Flare cross slope is greater than 10%			
Curb ramp running slope is greater than 8.3%		X	
Blended transition running slope is greater than 5%			
Cut-thru ramp running slope is greater than 5%			
Curb ramp cross slope is greater than 2%		X	
Cut-thru ramp cross slope is greater than 2%			
Curb ramp width is less than 48"			
Cut-thru ramp width is less than 60"			
Permanent obstruction (>0.25') in curb ramp/landing/flares			
Turning space does not exist and is needed			
Turning space length is less than 4' (or 5' when constrained)			
Turning space width is less than 4' (or 5' when constrained)

Corner 1 No Ramp (12)

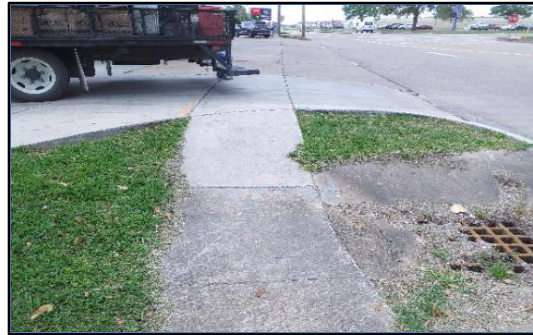
Ramp 4A

Turning space running slope is greater than 2%			
Turning space cross slope greater than 2%		X	
Temporary obstruction (>0.25') in curb ramp/landing/flares			
Non-compliant detectable warning surface (DWS)			
No detectable warning surface (DWS)			
Curb ramp transition onto roadway is greater than 0.25'			
Counter slope of the gutter or street at the foot of the curb ramp is greater than 5%			
Ponding occurs at base of curb ramp

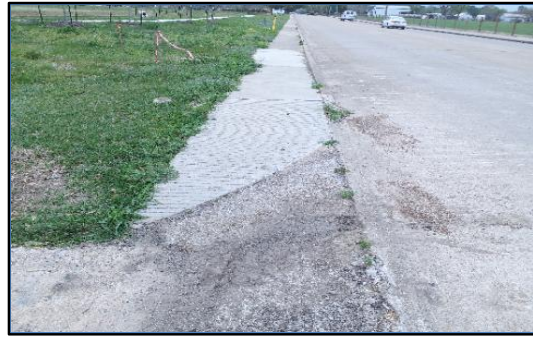
Ramp 3A

Curb Ramp Issues	Curb Ramp ID ('z', 'l', or 'CN' in ramp label indicates no existing ramp)		Possible Solutions
	2A	3A	
Curb ramp does not exist and is needed			Remove and replace curb ramp
Curb ramp does not land in crosswalk			
No 4' x 4' clear space at base of curb ramp			
Curbed side is not 90° or has traversable adjacent surface			
Flare cross slope is greater than 10%			
Curb ramp running slope is greater than 8.3%			
Blended transition running slope is greater than 5%			
Cut-thru ramp running slope is greater than 5%			
Curb ramp cross slope is greater than 2%	X	X	
Cut-thru ramp cross slope is greater than 2%			
Curb ramp width is less than 48"	X		
Cut-thru ramp width is less than 60"			
Permanent obstruction (>0.25') in curb ramp/landing/flares			
Turning space does not exist and is needed			
Turning space length is less than 4' (or 5' when constrained)	X		
Turning space width is less than 4' (or 5' when constrained)
